## HAZARDS RESULTING FROM IMPROPER BUILDING DRAINAGE SYSTEM BY THE USE OF BIM

Grzegorz Wrzeński ✉

Institute of Civil Engineering, Warsaw University of Life Sciences – SGGW

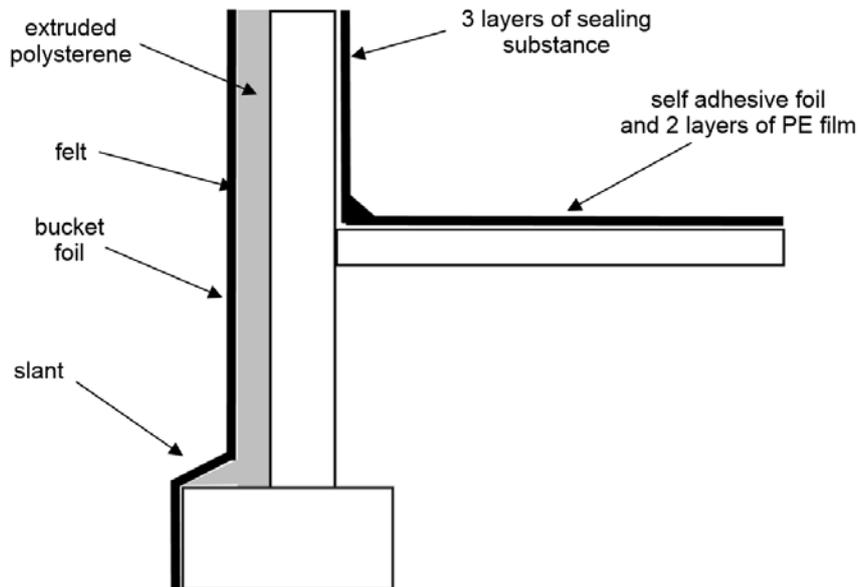
As a protection method against the groundwater and moisture in the underground part of the building, the developer put a layer of a bituminous material and roofing felt. This method proved insufficient and after the building was used for several years, the water infiltrated the building. The developer then applied external and internal insulation of the building foundations as a protection method. This repair was carried out under the warranty which covered the building for five years from commissioning.

the junction of the wall with the foundation, a facet of quick-setting mineral sealing material was applied in order to avoid stress in the waterproofing layer. The external and internal insulation of the foundations of the residential building is shown in Figure 3.

**Fig. 3.** The external and internal insulation of the foundations of residential building

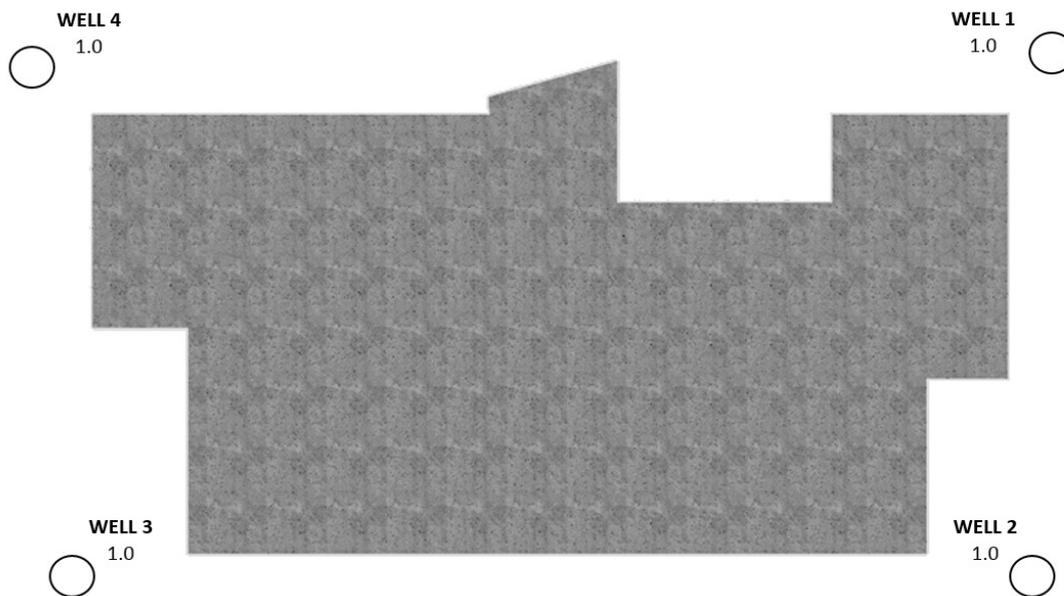
Due to the lack of effectiveness of the applied waterproofing, four PVC wells with an internal diameter of 1 m were constructed (Fig. 4). Holes with a diameter of 0.30 m were made in the bottom of the wells and on their sides in order to let the water inside the wells.

**Fig. 4.** PVC wells used to lower the groundwater level around the building

The wells were placed at a distance of 1 m from the building. From the wells, the water was pumped using submersible pressure pumps into the collective well and further to the storm water drainage system located in the street. This system was activated several times a day when the water began to appear on the floor of the underground part of the building. This reduced the level of the underground water near the building and allowed for normal use of the underground part of the building.

The location of the well in sandy soils and the lack of a filter in the drilled inlet holes of the well caused water and soil to be displaced into the well through the inlet holes. The soil was regularly removed from the inside of the well. After a few years of using the described drainage system, scratches appeared on the foundation slab and one of the outer walls of the building. Experiments conducted showed that the soil near the building was probably loosened over a considerable area. This could lead to a construction disaster. The reason for the loosening was the soil and water getting inside the well. As a result of the actions taken, the PVC wells were removed and the well holes were filled with sand. As a reinforcement procedure for the loosened soil, it was recommended to stabilize the soil around the building by jet grouting method. However, this method was rejected due to the lack of funds. Permanent observations of the settlement of the building were initiated.

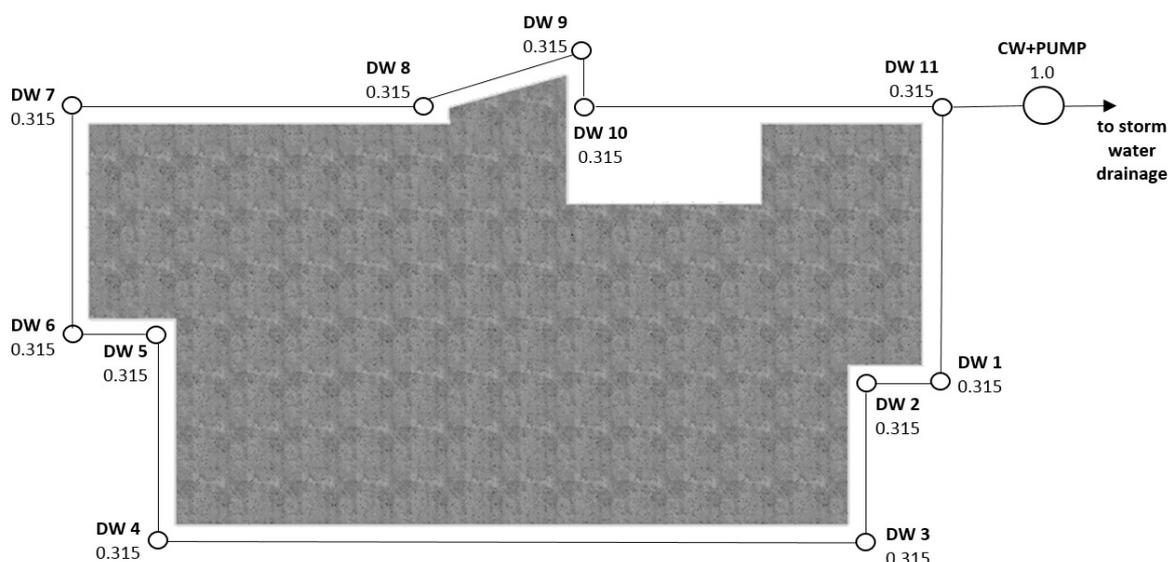
**Fig. 5.** The external drainage system used to drain the residential building

The lack of effectiveness of the currently applied methods of securing the underground parts of the building against groundwater led to the search for new methods. Permanent drainage of the building with external ring drainage was proposed. Drainage was carried out at a distance of 2.5 m from the walls of the building, below the floor of the underground car park. Corrugated PVC pipes with a diameter ( $d$ ) of 0.113 m and a width of the inlet gap ( $s$ ) of 1.5 mm were used for drainage. The system consisted of four external inspection and sediment drainage wells with a diameter of 0.8 m and one collective well with a diameter of 1.0 m. Drainage pipes inclination ( $i$ ) of 3%. The drainage was protected against clogging with a double-layer mineral aggregate filter. The bottom layer adjacent to the filter was compacted aggregate with a fraction of 2/8 mm; the upper layer was coarse sand. The filter was selected according to the Abramov method. On the bottom of the trench, below the filter, a geotextile fabric with a filtration coefficient above  $25 \text{ m} \cdot \text{day}^{-1}$  was laid out. Geotextile fabrics are designed to create a separation layer between the drainage pipe and the subsoil. After completion of the drainage works, the terrain was appropriately shaped to create a slope from the building towards the drainage. The drainage water flows by gravity into the collecting well. Then, it is pumped out from the collecting well into the storm water drainage system located in the street. The external drainage is shown in Figure 5.

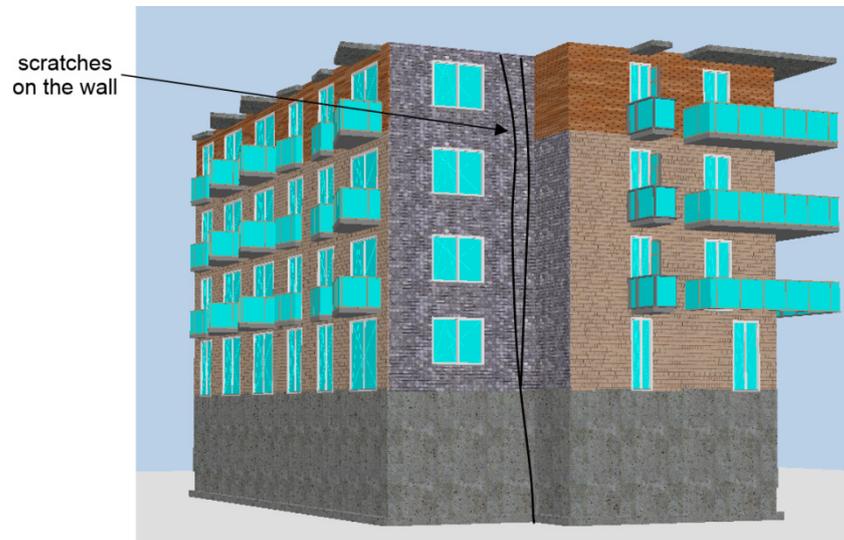
The use of wells caused uncontrolled activation of adverse filtration phenomena near the foundations. A particular threat to the stability of the building was the ill-considered removal of soil extracted from the water to the depression well which was not protected by a filter. The diameters of the inlet holes in the walls of drainage wells exceeded the allowable dimensions by several dozen times. This led to the loosening of the soil at the foundations and the creation of scratches in one of the building walls and the foundation slab. The width of the resulting scratches in the building reached 1.4 mm. The wall and foundation slab with scratches up to 1.4 mm are presented in Figures 6 and 7. In the analysed investment, the method of lowering the groundwater table using a well could have led to a construction disaster. Cracking of the foundation slab led to faster water penetration into the building, and the underground garage was decommissioned until drainage around the building was made. In the analysed case, it seems reprehensible that an expert opinion on the technical condition of the building was not sought. Instead, only provisional crack protection measures were introduced. The lack of professional subsoil reinforcement, e.g. by using the jet grouting method, also seems unacceptable. The expertise was probably not made due to cost savings, thus exposing the building to future failures.

**Fig. 6.** Wall with scratches up to 1.4 mm wide

The use of BIM technology to create a 3D model of the building enabled the provision of information about the building and the analysis of possible threats arising from the used drainage methods. A 3D model illustrated where the largest scratches occurred in the building and whether installations and load-bearing elements of the structure were at risk. The places where the largest scratches were formed are marked in Figures 6 and 7. Analysis of a 3D model shows that there are no building installations at the site of the scratches. However, the gable wall is a load-bearing element of the structure and scratches on its surface may cause threats to the building structure. Scratches of the foundation slab do not affect the load-bearing elements of the building. It is recommended to observe the places where the cracks formed and to take steps in case their width increases.

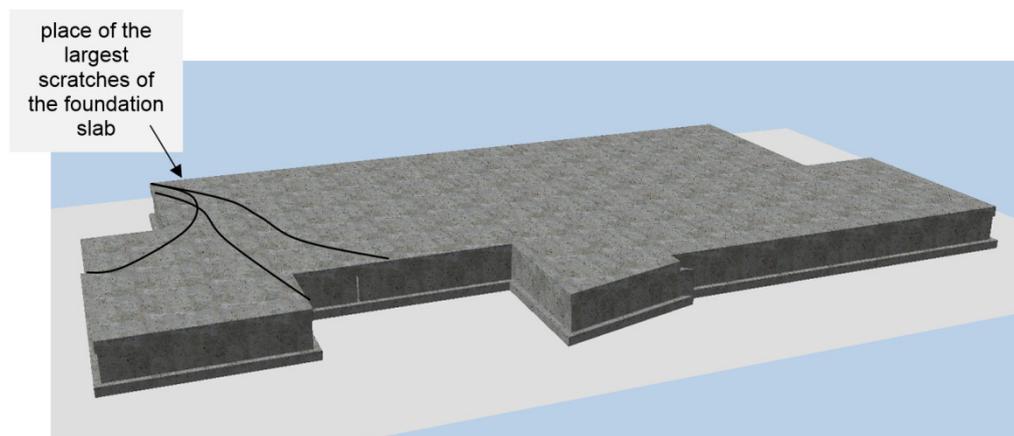
**Fig. 7.** Slab foundation with scratches
