RENOVATION OF BUILDINGS HAVING DAMP AND SALTED WALLS – CASE ANALYSES

Wacław Brachaczek✉

Faculty of Materials, Civil and Environmental Engineering, University of Bielsko-Biala, Bielsko-Biala, Poland

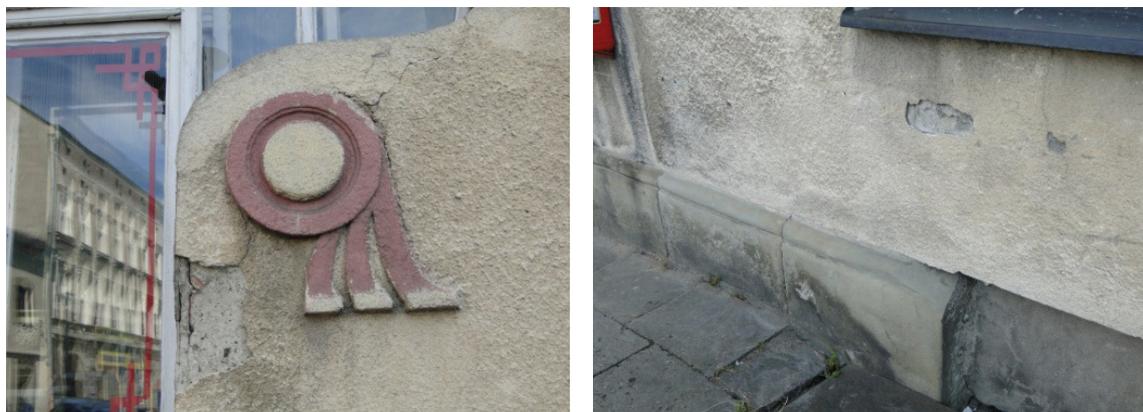
Based on the testing and examinations carried out, it can be concluded that the facades of both buildings are in very poor condition. In the case of the “Under the Frogs” tenement house, the plinth of the building made of stone is badly damaged (Fig. 2). A direct cause of plinth damage was splashing rainwater from the street, snow and ice accumulating in this part of

Fig. 2. Details of the facade of the “Under the Frog” tenement house at the Wojska Polskiego Square in Bielsko-Biała

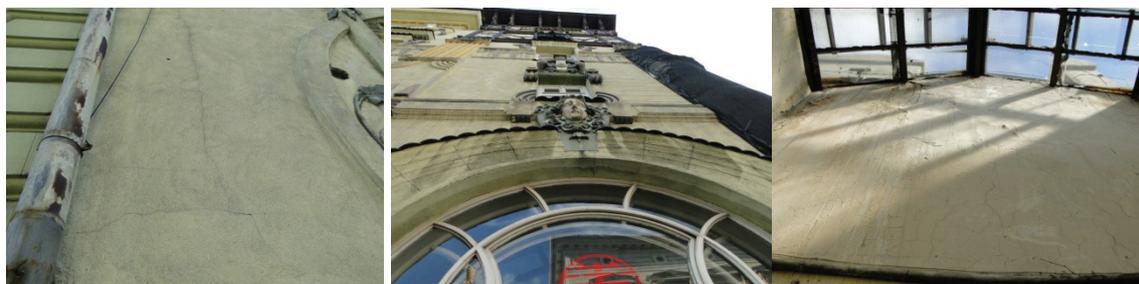
The building’s facades are in very poor condition, both in terms of technology and aesthetics (Fig. 3). Roof eaves, cornices under and over the windows are secured with flashings or plain tiles. Flashings are damaged, cracked, deformed, and do not fulfil their protective function. Lack of protection against water caused the mortar to be washed out, loosening strong compact parts of stucco elements. There are numerous defects on the surface of the cornices, moreover there are surface peels, stains, salting, cracks, biological corrosion. Penetrating and freezing water caused deep cracks and peeling off from the surface, individual loose elements fell off.

Fig. 3. Damage to the facade resulting from the impact of rainwater in the “Under the Frogs” tenement house in Bielsko-Biała

The destruction of plasters is so great that whole fragments of the stucco peeled and fell off. Some stucco elements made of thickly applied mortar are connected to the wall with nails and there is a risk that they could fall off. Damage caused by water and snow on cornices and the lack of a hydrophobic coating on the surface of the walls caused water to be absorbed into the plaster and brickwork joints. On the surface of the plasters, stains, moisture, water-soluble salts in the form of efflorescence are visible above the treatments, plasters are disintegrated, cracked, detached, sanded, with especially severe changes in the lower parts of window bands. Original lime plasters are heavily weathered and form a crust. In many places they have become detached from the wall. The main factors causing damage were: rainwater flowing down the facade with no flashings, water coming from capillary rise and atmospheric pollution.

In the case of the “Under the Frogs” tenement house, the first scope of renovation works involved inhibiting the destructive factors. To this end, in the first stage of work it is necessary to cut off the supply of water, both pulled up by capillary rise and flooding facades due to damaged and missing treatments. Fitting the missing tiles and reinstalling them in places where they protected cornices. In the next stage, removal of all secondary elements such as cables, advertisements, antennas being the source of local moisture penetration into the walls. The stone pedestal was cleaned of efflorescence and cement wash – manually or mechanically using chisels, hammers and scrapers. All joints were also removed. The stone defects were filled with sealing compound, the joints were filled with grouting mortar containing trass. The whole structure was protected with a water-repellent *Sempre Aqua* protekt preparation based on silicone microemulsion. To reconstruct the stucco details, the *Renowator 740* composite stucco mortar (*Sempre*) was used.

Since the tenement house is a peculiar piece of architecture of exceptional historic value, the next stage of the renovation will consist in emergency preservation of the facade. The removal of wet, loosened and detached plasters has been foreseen. It is planned to remove simple plasters in 50%, stucco details in over 30%. The plaster whose condition does not allow structural strengthening and gluing will be removed.

Well-preserved primary plasters and stucco elements will be reinforced with a reinforcing preparation based on silicone resins, silicates or fine-molecule silicates (tetraethyl silicates), e.g. Renowator 350 by Sempre Farby. As no capillary rise of groundwater from the foundations was found, the restoration of the horizontal moisture barrier was not performed. However, due to the partial moisture penetration in the walls, it was decided to replace the removed plasters with Renowator 545 – hydrophobic renovation plaster for diffusion plaster rendering. Application of the plaster will be preceded by proper preparation of the substrate, consisting in cleaning the wall of dust, dirt and grease. In order to avoid cracks and discoloration on the surface of the plaster coat, the brittle and weathered joints between the bricks will be removed to a depth of 2 cm. Places covered with mosses and algae will be cleaned with steel brushes and then disinfected with Aglesil algae remover. In order to reduce the water absorption before application of the rough coat, the surface will be wetted with water. The first plastering layer will be made of the Renowator 500 renovation coat, which will improve the adhesion of the next layer of renovation plaster to the substrate. Unification of the facade surface, especially in the places where primary plasters and renovation plasters are combined, will be made using Renowator 680 renovation lime coat. The protective layer will be silicone paint with reduced dirt adhesion and self-cleaning capabilities (e.g. Sempre Azzuro).

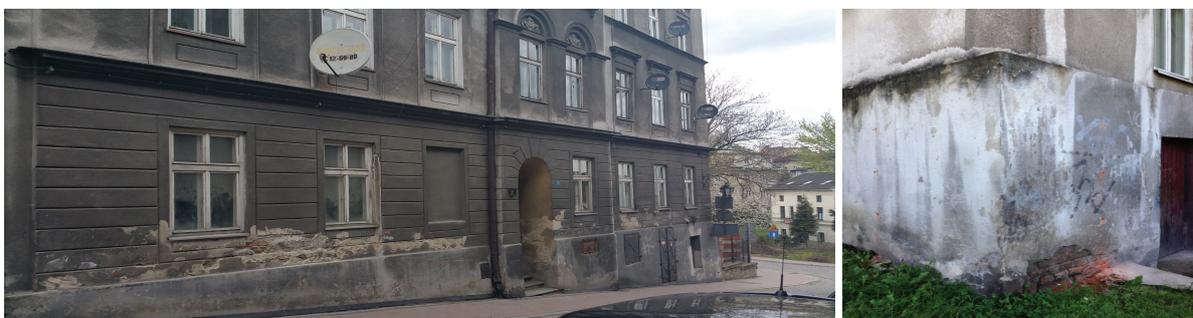
In case of the building at 2 Waryńskiego Street, humidity tests presented in Tables 1 and 2 indicated that the mass humidity distribution in the walls was high. A clear trend of the humidity level decrease along with the height of the measurement can be observed on all walls. This indicates the capillary rise of moisture in the wall and is the result of damaged horizontal insulation of the building walls or lack thereof. Moisture is pulled up from the ground by old bricks and mortar within a capillary system. In addition, an increase in humidity in the lower, unsecured vertical insulation zone (up to approx. 50 cm above ground level) may come from splashing rainwater. Also, the greatest damage in this building was observed in the bottom part of the plinth and in all places where the flashings were significantly damaged and ceased to fulfil their function (Fig. 4).

Fig. 4. House at 2 Waryńskiego Street, the figure shows the destruction of the walls caused by ground water rise

In the case of the building at 2 Waryńskiego Street, the first scope of renovation work included roof repair combined with the replacement of roof slopes with window joinery renovation, replacement of flashings together with rainwater drainage system. In order to protect the building against the harmful effects of water coming from the ground, it is planned to restore the horizontal moisture barrier by injection. Due to the specific nature of this method, a waterproofing horizontal insulation just above the ground level was planned for all analysed walls, except for possible pressurized water impact. This will protect the building parts above the ground against moisture migrating from the ground. The varied nature of the foundations, mostly made of stone, and the voids or gaps occurring in it, determined the use of low-pressure injection

combined with pre-injection to restore horizontal insulation. The pre-injection consists in pre-filling holes with sealing mortar, whose task is to fill gaps and voids in the wall. Optionally, in the case of stone and brick walls with a diverse structure, good effects are obtained by using gravity injection with an agent of high consistence. This product contains polysilicate compounds, well penetrating building materials. They form a tight moisture barrier as a result of a change in surface tension of the pores. The advantage of this product is high consistence which facilitates application in walls of high heterogeneity. In order to eliminate the impact of splashing rainwater on the humidity of the walls, it was recommended to secure the plinth zone of the walls (at a height of up to 50 cm) with vertical sealing mortar.

Due to the considerable destruction of plasters, it was necessary to remove them down to the brick layer. Most of the walls were in good condition, however they were very wet and salted. The condition of the bricks was very diverse, with some of them strong, and others weak and brittle. The mortar which the joints were made of was largely rotten and brittle. At some windows, especially in the upper floors of the southern facade, cracks of cornices and bands around the windows could be observed. Due to the high saltiness and dampness of the walls, higher than in the case of the “Under the Frogs” tenement house, the use of traditional cement and lime or cement plasters for renovation would be a temporary solution. Due to the low diffusivity of water vapour, on damp and salted walls, such mortars tend to peel away and crack. This phenomenon may be affected by such factors as stress caused by salt crystallization, as well as mismatching of plaster properties to the substrate. According to Brachaczek (2018b), a single type of renovation plaster with universal properties should not be used to renovate historic buildings. There is probably no such plaster available anyway. The walls differ in water sorption coefficient, strength, diffusion resistance, etc. Whenever choosing plasters, their compatibility with the substrate needs to be checked. Damp walls with a low water sorption coefficient should not be covered directly with hydrophobic plasters. The low sorption coefficient of the walls means that the walls dry slowly and the water is stored in them for several

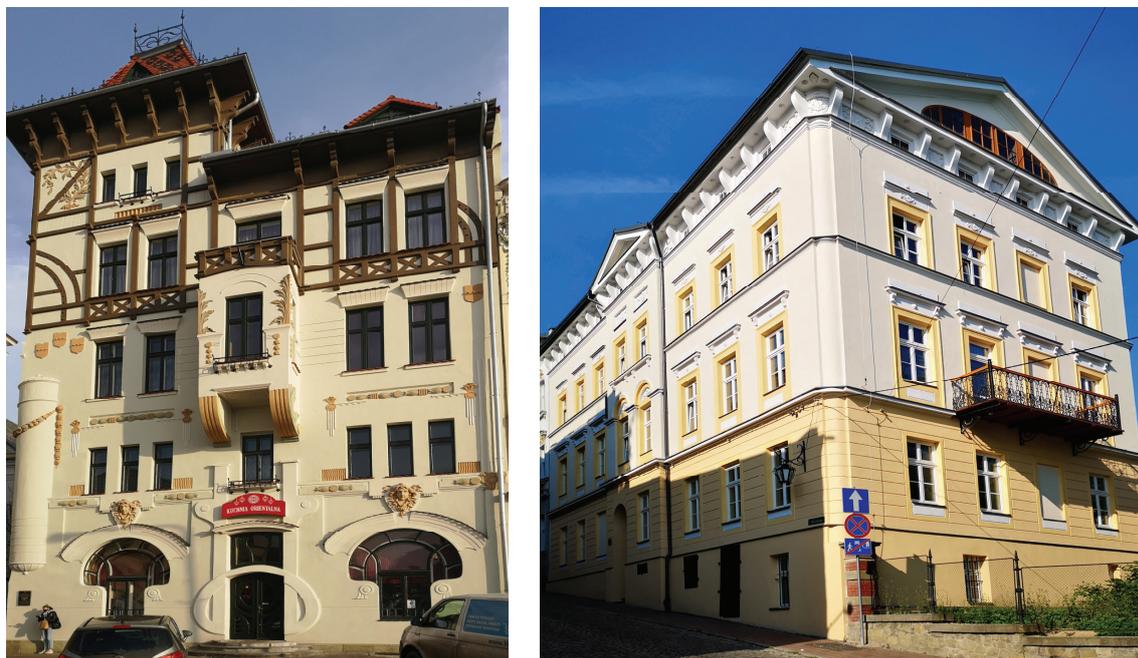
Fig. 5. House at Wojska Polskiego Square (on the left), tenement house at 2 Waryńskiego Street (on the right) in Bielsko-Biala after renovation

buildings and the analysis of the cases described in the literature (Dudás & Terjék, 2015; Misiewicz, 2016). Figure 5 shows the state of elevation at Waryńskiego Street three years after renovation and the elevation of the building called Under the Frogs after a year.

In case of the tenement house at Waryńskiego Street, the dampness of lower than 3% was obtained after three years from renovation. The appointed time is consistent with the results achieved by (Gosztyła, Leś & Sikorski, 2017) in case of the tenement house at the main square in Rzeszów, where renovation plasters were also applied for renovating damp walls. The qualities of the plasters are frequently overestimated. One cannot expect renovation plasters to be effective if the source of dampness has not been removed. In such cases the plasters lose their properties as a result of storing more salt caused by capillary suction, which considerably shorter their durability (Dudás & Terjék, 2015). It is bad practice of some contactors to apply renovation plasters in the dampest spots, as well as to combine them with lime-cement of low permeability of water vapour. In this case the wall still remains damp and the dampness in the lime-cement area
