ANALYSIS OF STRENGTHENING OF THE FOUNDATIONS OF HISTORIC BUILDING

Elżbieta Kokocińska-Pakiet^{1✉}, Dariusz Bajno²

Key words: monument, settlement analysis

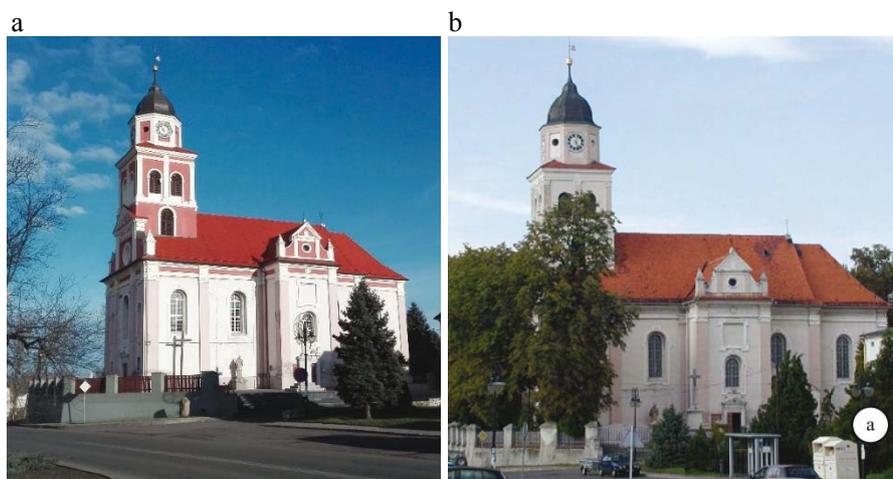
One of the monuments in Opole Province which underwent repair and conservatory works is the Church of Saint George in Prószków (Fig. 1). On 12 July 1954 the church was entered into the register of monuments of Opole Province (Bajno, 2014). The building of the St. George Church in Prószków dates from 1578. It was founded by the Baron Jerzy Prószkowski. Around the church building a parish, school and hospital were also built (Bajno, 2013).

Fig. 1. Saint George Church's view: a – 2018 (photo by E. Kokocińska-Pakiet), b – 2008 (Bajno & Bednarz, 2010 photo by D. Bajno)

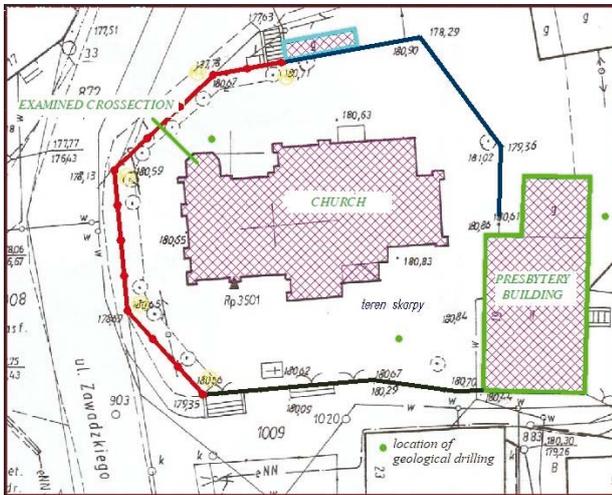
Assumptions: In the paper it has been discussed the least favourable intersection (northern and western part of the church – Fig. 2), according to the load list

Fig. 2. The location of the church building (prepared by D. Bajno, E. Kokocińska-Pakiet). Deployment of the retaining wall and geological boreholes

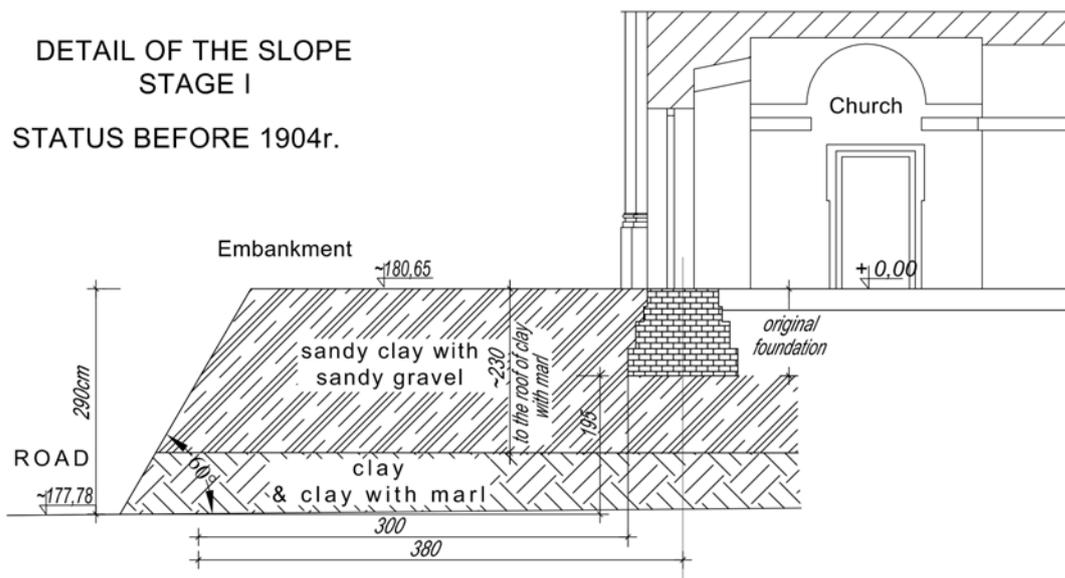
1. At the first stage (Fig. 3) – 1687 – the church was rebuilt in the new Baroque style, at the old foundations the orientation of the church was changed. The slope was not secured by any of masonry elements. In light of the fact that no documents of that time were preserved the slope gradient of 60° has been assumed. Currently there is a road along the slope. Taking into account the fact that main roads do not change their location, the road along the scope has been also assumed. The load that affects the church foundations from the side of the bell tower wall has been adopted at the value of $765 \text{ kN}\cdot\text{m}^{-1}$.

Fig. 3. The first stage – before 1904

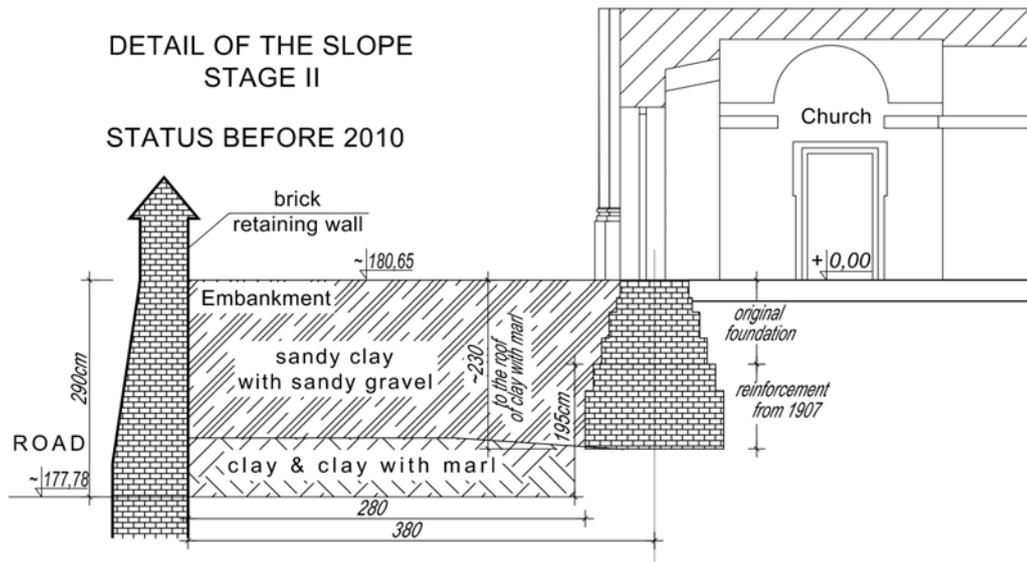
2. At the second stage (Fig. 4) – 1904–1907 – the foundations were strengthened by underpinning of the existing foundations by sections of the length of about 1.0 m. The underpinning was provided with solid brick and lime mortar. The same time the retaining wall was built and fencing around the church area was installed. The solid brick wall on lime mortar survived up to 2010. The load as at stage I.

Fig. 4. The second stage – the status before 2010

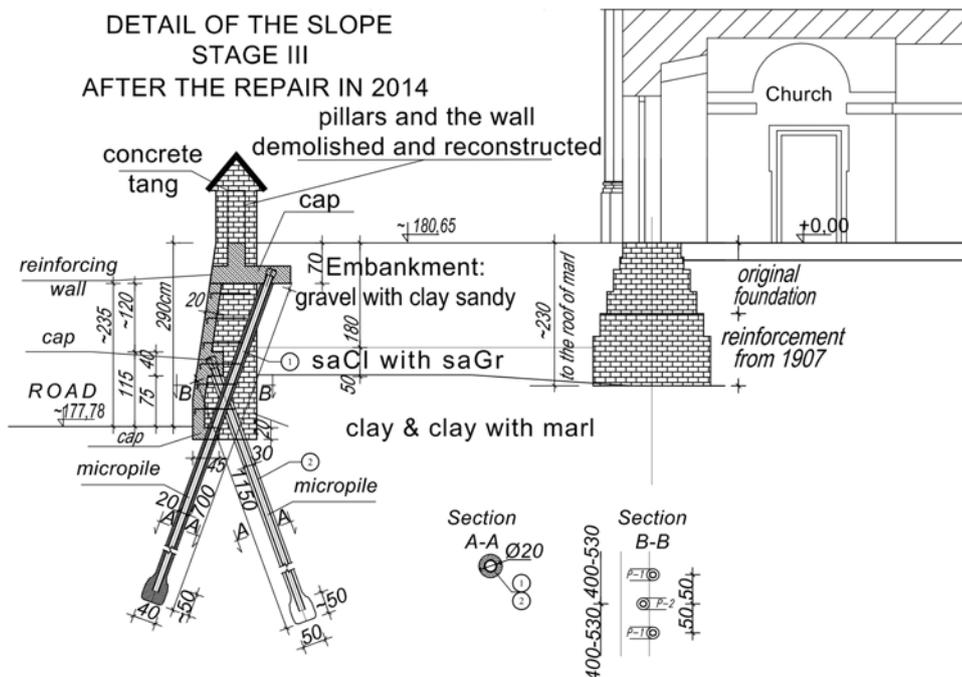
3. At the third stage (Fig. 5) – after 2014 – the retaining wall was strengthened by reinforced concrete coating around the existing wall that the retaining wall became more massive. What is more, it was reinforced with micropiles drilled in turns one from the

church side and the other from the road side, every 0.5 m on average.

Fig. 5. The third stage – the status after the repair in 2014

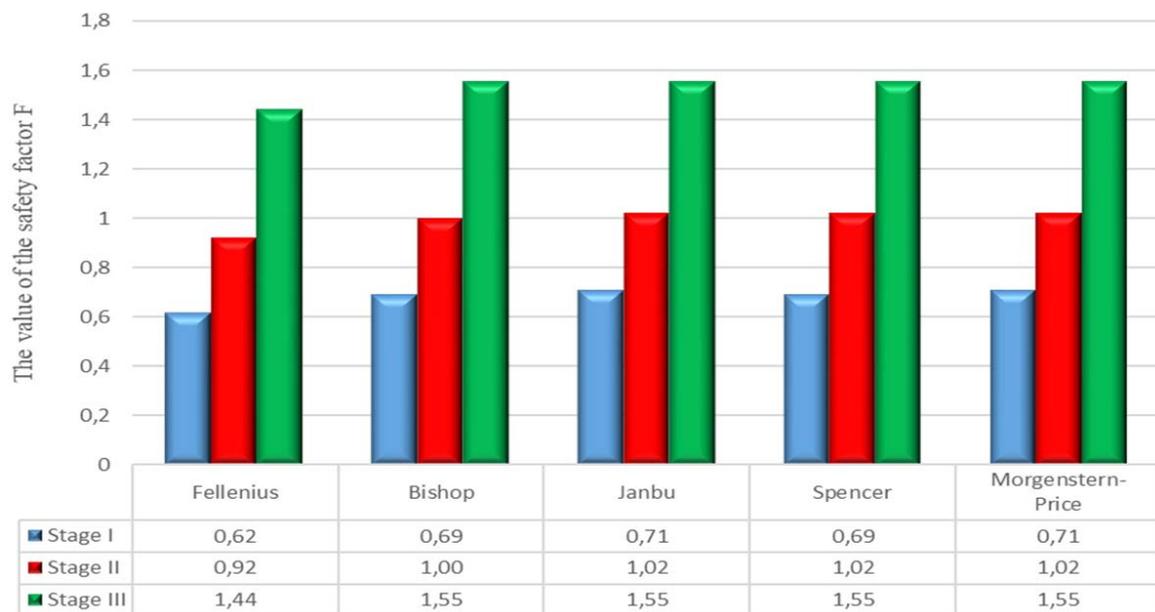
For further calculations it has been selected the ones that are most extensively described in the literature (Abramson, Thomas, Sharma & Boyce, 1996; Wysokiński, 2006). All calculations were optimized in respect of the most dangerous slip surface to which the F factor was stipulated. The obtained factors of safety have been compared and juxtaposed in Figure 6.

Following currently binding standards in order to declare slope stability the factor of safety F should be 1.5. The studies indicate that for such value the losses of stability of the existing slopes do not occur. Provided the factor obtained the value between 1.3 and 1.5 then such structure should be monitored on a continuous basis.

Fig. 6. Comparison of factors of safety in the respective stages of the structure “existence”

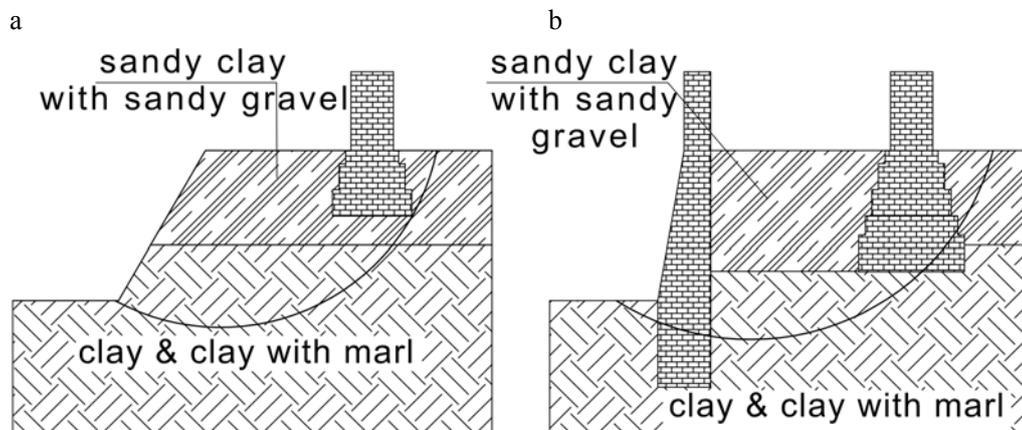
The first evaluation conducted in 1904 aimed at determining the causes of numerous cracks that had occurred on the church walls. In the stage I of the structural behavior that had been assumed (Fig. 7a), the average factor of safety for 5 methods was $F = 0.684$, which means that the slope is not stable. The church building was settled on the slope of the height of about 1.25–2.70 m above ground level. Originally the structure had been settled only partially on natural soil and in the northern part on made soil. The fact that the slope had not been secured at the first discussed stage resulted in gradual deterioration of the church building. The location of the averaged slip surface in Figure 7a indicates that it penetrated just before and under the original foundation of the church. The foundation shift resulted from a slip line caused numerous cracks of the church vaults and walls, the reaction to which were attempts of preventing it by anchoring of the church walls.

The stage II of the discussed changes was conducted concerning deeper foundations and the slope prevented from sliding by the retaining wall built with solid brick and lime mortar (Fig. 7b). The loads of church roof, ceiling and walls and the road remained unchanged. Nevertheless, the average factor of safety

Fig. 7. Calculation model adopted for the respective stages of church settlement reinforcement: a – I stage before 1904, b – II stage the status as of 2010

for the slope was still 0.997. It shows that the slope remained unstable. After the reinforcement, the slip surface, which runs through the new part of the brick foundation reinforcement and the wall reinforcement, went down deeper. Maximum value of the total force of the horizontal impact exceeded calculation ground resistance for slip about 10%. In spite of this, no changes were found in the construction of the wall and the embankment. The uncover during the wall repair

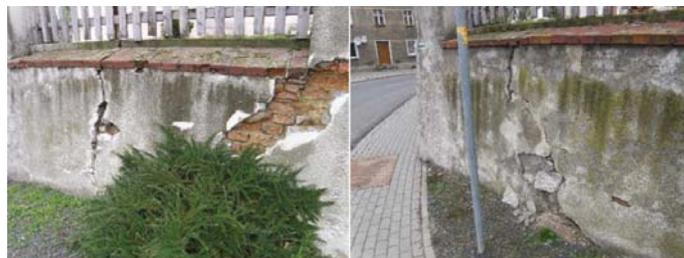
indicated the presence of field stones in the foundation, the bearing capacity thereof cannot be estimated. The instability of the slope led to deterioration of the retaining wall (Fig. 8) and further gradual deterioration of the church, and new wall cracks.

Fig. 8. Damage to the brick retaining wall (Bajno, 2014, photo by D. Bajno)

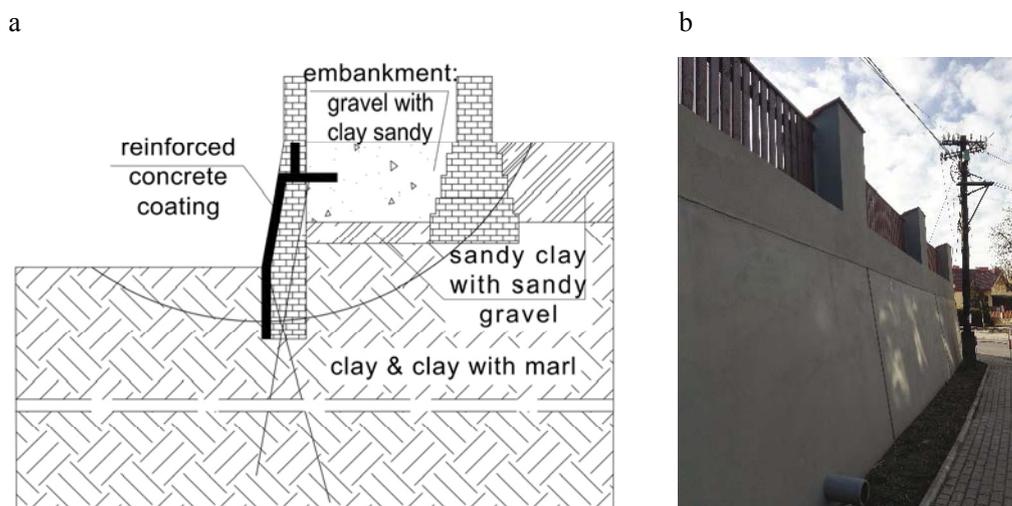
Fig. 9. Calculation model adopted for the respective stages of church settlement reinforcement: a – the stage after the repair in 2014, b – wall's view after the repair (photo by E. Kokocińska-Pakiet)

that runs at the base of the wall. The average factor of safety that was obtained is 1.528. It falls within the standard limits. The slip surface estimated under the calculations runs through the original and reinforced foundation and through the base of the retaining wall and it ends at the Province road level. Such solution, however, requires continued observations whether further damage to repaired wall and church's wall will occur.

The III stage of calculations involved the following changes: the retaining wall was strengthened by reinforced concrete coating as well as the pivot protruding from it on which the brick wall was reconstructed. The

reinforced concrete coating was additionally anchored with two micropiles (Jurczakiewicz & Kaczmarczyk, 2011), mounted onto the coating. The drilled micropiles were mounted in turns every 0.5 m. One was 11.5 m long and its diameter was 300 mm, the other one – the length of 7 m and diameter of 200 mm (Fig. 9a).

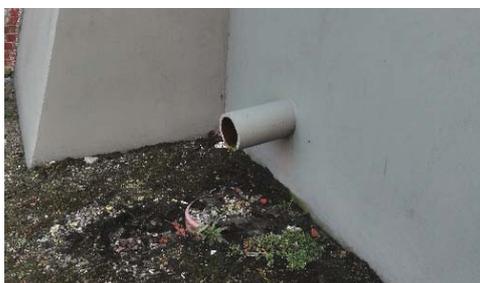
neighbouring by the Province road with heavy traffic of trucks, which may adversely affect the slope stability. According to the recommendations (Pozzi et al., 2008) the outlet pipes discharging water from the church roof were repaired, which prevents the slope from soaking up. Meanwhile the chestnut trees, which prefer damp soils not wetlands and their root system is flat, just under the surface and widely spread out, were removed. However, it is a disadvantage that the root system of the cut down trees has remained. Presently, they do not pose a threat but decaying tree roots may trigger off deeper penetration of rainwater, which may impact the slope stability. The leaking stormwater drainage system has been repaired and the directions of the rainwater discharge have been put in order so the church walls do not soak up. However, instead of installing discharge pipes to the combined sewage system the solution that has been employed may result in soaking up of the retaining wall base (Fig. 10).

Fig. 10. Water discharge from the church square (photo by E. Kokocińska-Pakiet)
