THE IMPACT OF RIVERBED EROSION ON THE TECHNICAL CONDITION OF WATER ENGINEERING STRUCTURES: THE EXAMPLE OF VISTULA RIVER REACH NEAR THE OUTLET OF WILANÓWKA STREAM

Łukasz Krysiak✉

Faculty of Building Services, Hydro and Environmental Engineering, Warsaw University of Technology, Warsaw

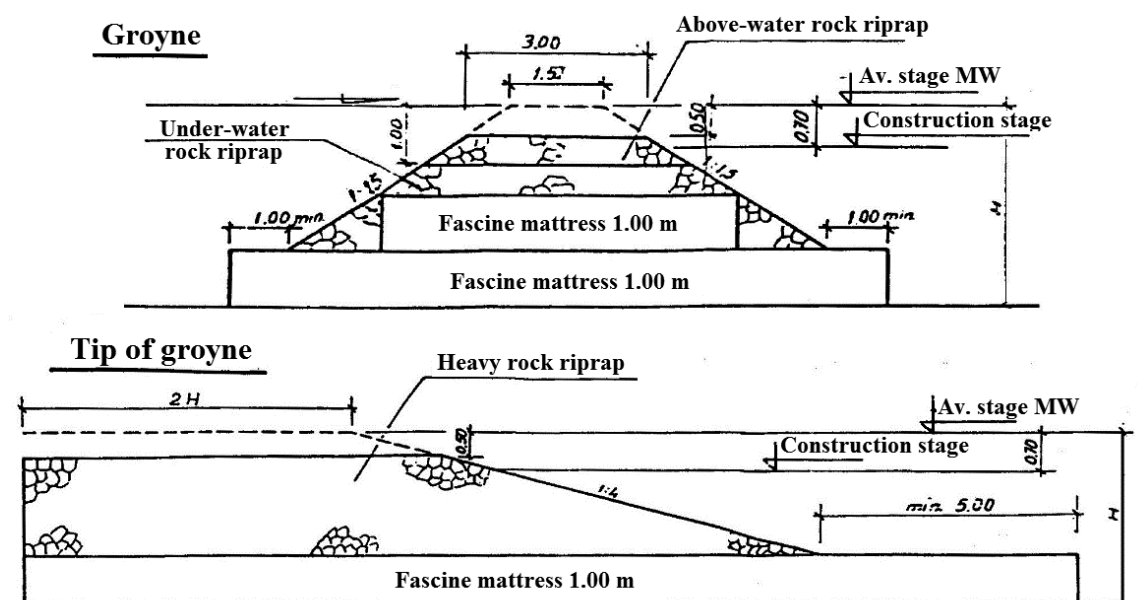
The wing dams (groynes, spurs) “push” the main water current away from the bank and concentrate it inside an assumed cross-section. Their tips are located in an area of constantly turbulent water flow and they are founded on the bottom area subjected to concentrated riverbed erosion. Main body of the groynes is built of heavy material resistant to rapid water flows, the slopes (especially at the tip) have a mild inclination, foundations are traditionally constructed using mattresses made of fascine and rocks to prevent wash-outs (Fig. 4).

Fig. 4. Cross-section of a wing dam (top) and its tip (bottom) (RZGW, 1990s)

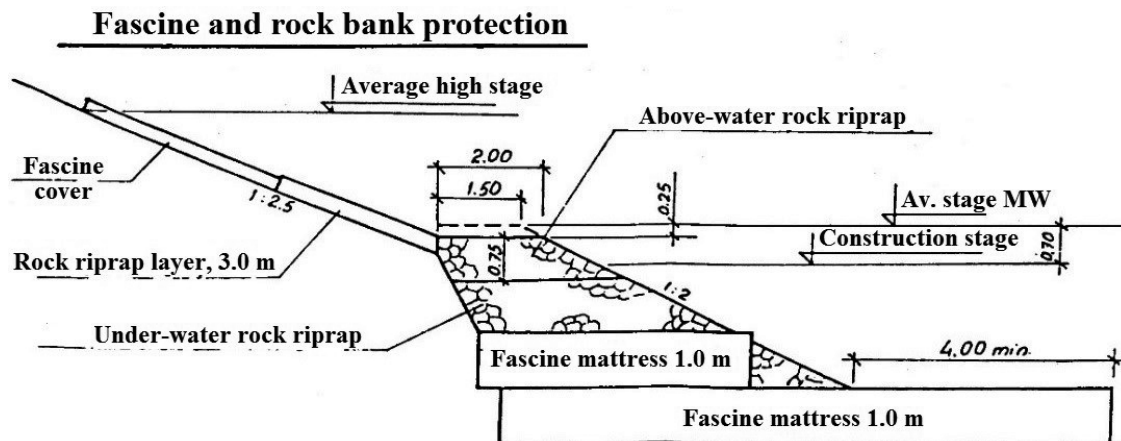
the groynes, they are subject to the dynamic action of the water current and often founded in an area of concentrated bottom erosion. Their slopes are covered with heavy stone riprap and shaped using mild inclinations. Foundations are again made of fascine mattresses (Fig. 5).

Fig. 5. Cross-section of bank-protection (RZGW, 1990s)

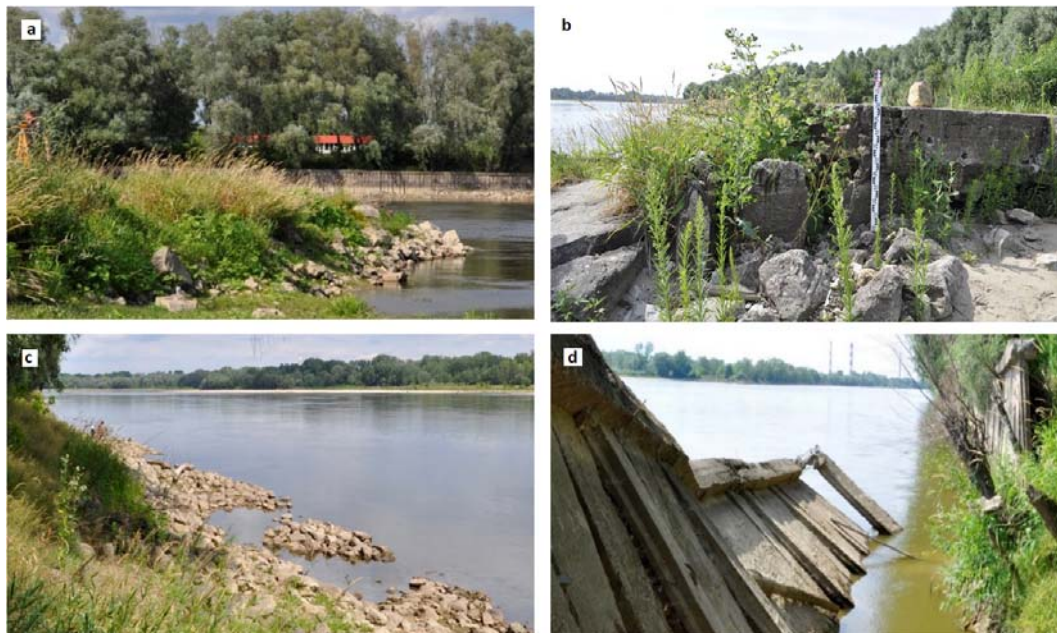
The groynes made of stone riprap positioned within the analysed river reach have deteriorated to various extents. Visual assessment of some of these structures (Kuzniar et al., 2017) suggests loss of initial shape and loosening of riprap, especially at the tips (Fig. 6a). Similar issues also affect groynes of different structure, including those with concrete slab slope facing (Fig. 6b).

Visual assessment of the bank-protecting structures in the analysed river reach suggests that they undergo degradation at varied rates. It affects rock riprap structures and walls built of concrete sheet piles (Fig. 6c, 6d).

Fig. 6. River engineering structures (Kuźniar et al., 2017): a – left bank groyne, about 501.50 km, loosened stone riprap and irregular shape of the structure; b – left bank groyne, about 506.50 km, fault in the concrete body of the structure measuring approximately 80 cm, concrete slope facing destroyed; c – left bank protection, about 504.50 km, loosened stone riprap and sliding of loose boulders; d – right bank protection wall, about 501.40 km, loss of stability of segments of the concrete sheet pile wall

Crests at the tips of the groyne located within the analysed river reach appear to be sinking, the decrease in elevation reaches up to 2 m (destruction of the structure). Most river regulation structures show symptoms of instability, such as slope sliding, loose boulders, loss of shape, washouts, destruction of slope facing and collapse of sheet piles. One of the factors contributing towards the deterioration of the structures is deep riverbed erosion, which results in washouts and decreasing elevation. Their foundations, made of

fascine mattresses (Figs. 4, 5) are probably gradually sinking following the changing elevation of the riverbed bottom, while their original shape is likely distorted. The concrete sheet pile walls (Fig. 6d) are subjected to new loading conditions, as stabilizing forces related to water levels and soil depth on the riverbed side have significantly decreased.
