ARCHITECTURAL, MATERIAL AND CONSTRUCTIVE SOLUTIONS IN DWELLING HOUSES OF SELECTED ORGANIC FARMS IN LUBLIN VOIVODESHIP

ABSTRACT

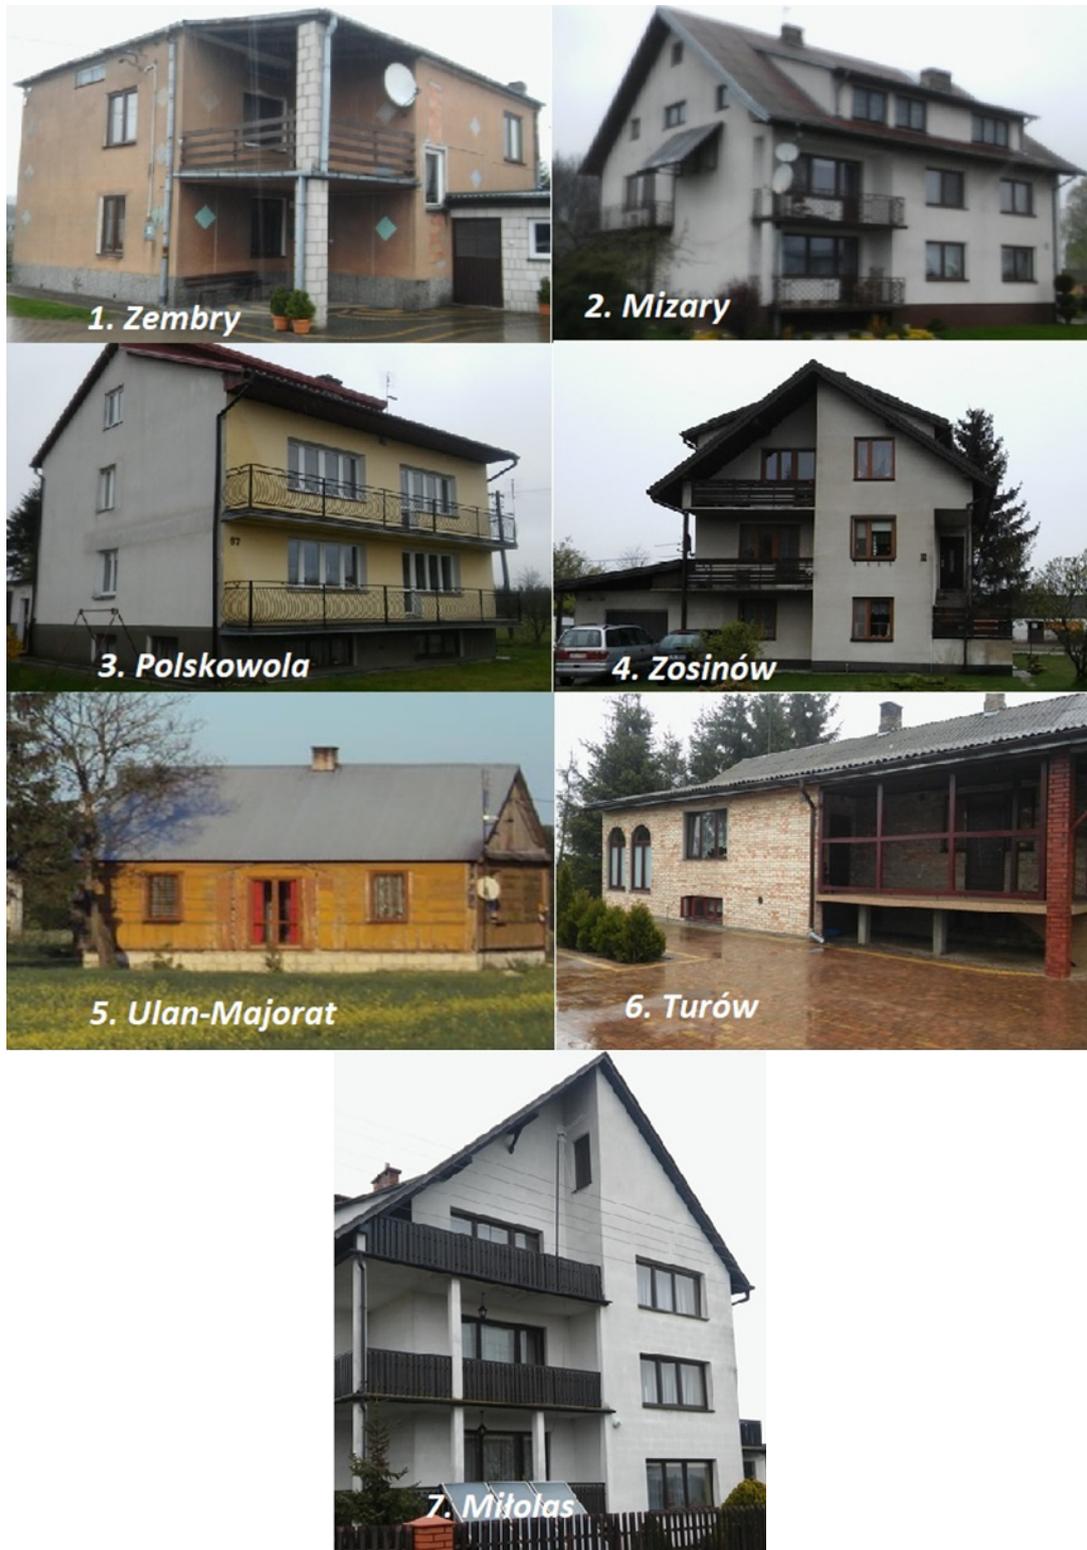
The dwelling house was erected in the 1980s. It is located on a farmstead plot. It is a two-storey house without basement, with non-usable attic, it has the dimensions 7.0 × 7.0 m and the height 7.5 m. The house has been constructed on ferroconcrete continuous footings and concrete foundation walls. The walls of the ground and first floors are one-layered, plastered, built of ceramic hollow bricks with the thickness 25 cm. The cover is a closely-ribbed Teriva[®] ceiling. The roof has been built as a rafter construction, it is a hip roof covered with a flat metal sheet. The internal stairs is a stringer construction made of wood (Fig. 1).

constructed with purlins and collar ties, covered with a corrugated sheet; the attic has been insulated with a mineral wool and finished with gypsum and cardboard plates. The internal stairs have been made of ferroconcrete, supported on the wall and beam (Fig. 1).

The house was erected in 1989. It is a two-storey house, with full basement and usable attic, it has dimensions 8.0 × 6.0 m and the height 9 m. The house has been constructed on ferroconcrete continuous footings and the basement concrete walls. The walls of the overground storeys are three-layered: the carrying layer is made of ceramic hollow bricks with the thickness 19 cm, the thermal insulating layer – the Styrofoam[™] (10 cm) and the facing – a lime-sand brick (12 cm). The ceiling is ceramic, closely-ribbed. The roof is the collar beam construction, covered with a steel corrugated sheet. The attic has been insulated with a mineral wool and finished with gypsum and cardboard plates. The stairs have been made of ferroconcrete, supported on beams (Fig. 1).

The house was erected in 1999 as two-storey without basement, with usable attic, it has the dimensions 8.0 × 9.0 m and the height 11 m. The building is supported on ferroconcrete continuous footings and foundation concrete walls. The walls of the ground and first floor have been made of concrete hollow bricks (24 cm) outside and cavity brick (12 cm) inside, without insulation. The ceiling is closely-ribbed, made of the Teriva[®] hollow bricks. The roof framing is a rafter construction, covered with a steel corrugated sheet. The internal stairs have been made of ferroconcrete, supported on the wall and a beam (Fig. 1).

Fig. 1. Dwelling houses in the farms 1–7. After the number of the farm, a name of its village is placed (own elaboration)

(starting from the outside): wooden balks connected with a tongue-and-groove joint (19 cm), cement and chip boards (10 cm) and plank board (1.5 cm). The ceiling is naked, made of wood. The house has the gable roof with framings supported on the ceiling beams. The roof is covered with roofing paper. There are no stairs in the building, the attic is accessible with use of a ladder (Fig. 1).

The dwelling house was erected in 1990 as a one-storey house with basement, with non-usable attic, it has the dimensions 11.0 × 6.0 m and the height 4.5 m. It has been constructed on ferroconcrete continuous footings and concrete foundation walls. The walls of the ground floor have one layer made of concrete hollow bricks (25 cm). The ceiling is a beam ribbed construction, made of wood. The house presumably has the gable roof, it is covered with cement-asbestos boards. There are no stairs in the building (Fig. 1).

The house was erected in 1996 as a two-storey, with full basement and usable attic, it has dimensions 10.5 × 9.0 m and the height 12.5 m. The foundations are ferroconcrete continuous footings on which the basement concrete walls have been constructed. The walls of the overground storeys have been made as a cavity wall with non-ventilated 2 cm thick air cavity between the aerated concrete carrying layer (24 cm) and ceramic brick covering layer (12 cm). Then, the Styrofoam™ insulation has been made (10 cm). The ceiling is monolithic, reinforced in two directions, made of ferroconcrete. The roof is the collar beam construction, covered with a steel flat sheet. The stairs have been made of ferroconcrete, supported on the wall and beams (Fig. 1).

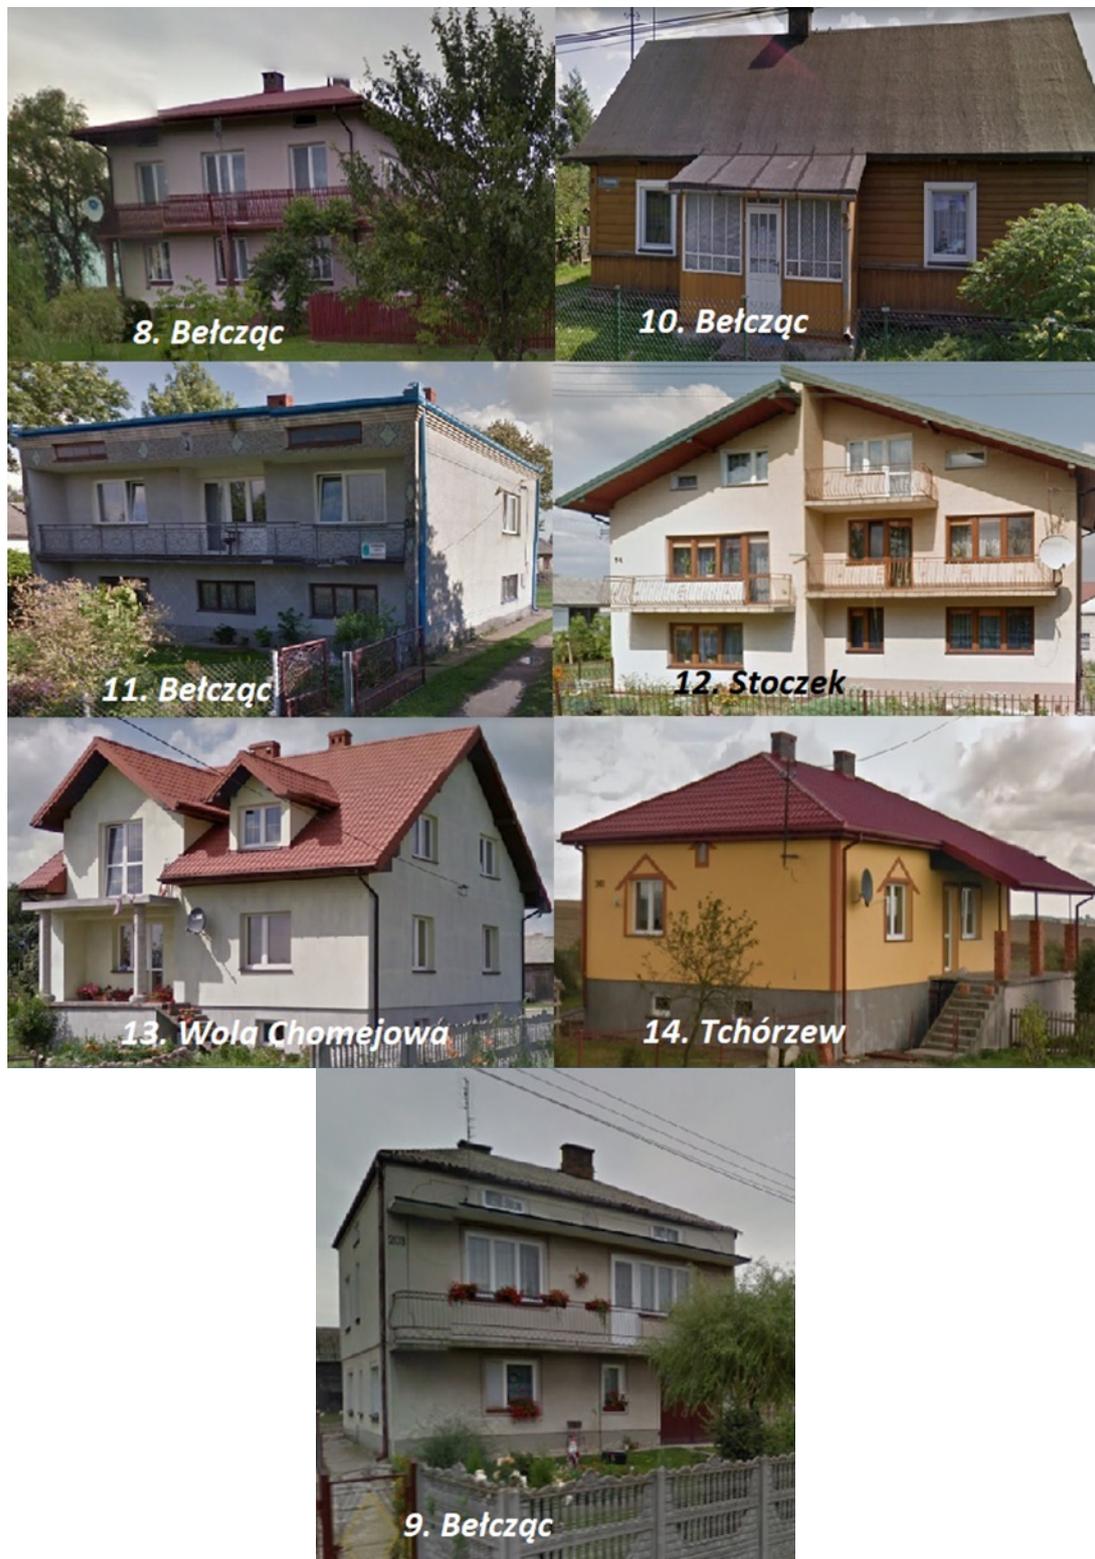
The walls are not additionally insulated. The ceiling is closely-ribbed, ceramic. The house has the “envelope” roof covered with roof tile sheets. The vertical communication in the house is provided by ferroconcrete stairs supported on beams (Fig. 2).

The house was erected in 1986 as two-storey, with basement, with non-usable attic, it has the dimensions 7.5 × 9.0 m and the height 8 m. The building has been erected on ferroconcrete continuous footings and basement concrete walls. The overground floors have been built as a cavity wall having a concrete block layer (24 cm), a non-ventilated air cavity (2 cm) and a ceramic brick layer (19 cm). The ceiling has been made of ferroconcrete slabs (10 cm). The house has the “envelope” roof covered with cement-asbestos boards. The internal stairs have been made of ferroconcrete, supported on beams (Fig. 2).

The dwelling house was erected in 1976 as a one-storey house without basement, with non-usable attic, it has the dimensions 8.0 × 6.0 m and the height 6 m. It has been constructed on foundation walls made of crushed stone bonded with cement mortar. The walls of the ground floor have been made of wooden balks connected with a tongue-and-groove joint, a reed mat insulation and plank board as the elevation. The ceiling is naked, made of wood, the ceiling beams support the rafter-beam roof covered with roofing paper. There are no stairs in the building (Fig. 2).

The dwelling house was erected in 1982 as a one-storey house with partial basement, with non-usable attic, it has the dimensions 8.5 × 9.0 m and the height 8 m. It has been constructed on ferroconcrete continuous footings with concrete foundation walls. The walls of the ground and first floors have been built as a cavity wall with an aerated concrete layer (24 cm) and a ceramic hollow brick layer (19 cm) with a non-ventilated air cavity (5 cm) between them. The ceiling has been made of ferroconcrete slabs (10 cm). The house has the “envelope” roof covered with steel sheet. The stairs have been made of ferroconcrete, supported on beams (Fig. 2).

Fig. 2. Dwelling houses in the farms 8–14. After the number of the farm, a name of its village is placed (own elaboration)

The dwelling house was erected in 1999 as a one-storey house with partial basement, with usable attic, it has the dimensions 11.0 × 8.0 m and the height 9 m. It has been constructed on ferroconcrete continuous footings with concrete basement walls. The walls of the ground and first floors have been built as three-layered: of ceramic hollow bricks (19 cm), the Styrofoam™ (15 cm) and cavity brick (12 cm). The ceiling is closely-ribbed, ceramic. The roof has been constructed with purlins and collar ties, covered with roof tile sheets. The stairs are a steel construction filled with wood (Fig. 2).

The house was erected in 2003 as one-storey, with basement, with usable attic, it has the dimensions 7.5 × 9.0 m and the height 8 m. The foundation has been constructed as ferroconcrete continuous footings and basement concrete walls. The overground floors have been built as a cavity wall having a cellular concrete block layer (24 cm), ceramic brick layer (12 cm) and an air cavity (2 cm) between them. The ceiling is closely-ribbed, ceramic. The roof is the collar beam construction, covered with roof tile sheets. The internal stairs are self-carrying, made of wood (Fig. 2).

The house was erected in 1996 as one-storey, with basement, without attic, it has the dimensions 8.0 × 8.0 m and the height 5.5 m. It has been constructed on ferroconcrete continuous footings and foundation concrete walls. The ground floor walls have been built as three-layered: of ceramic hollow bricks (19 cm), the Styrofoam™ (15 cm) and cavity brick (12 cm). The ceiling is wooden. The roof is the “envelope” construction, covered with roof tile sheets. The internal stairs have been made of ferroconcrete (Fig. 2).
