DEVELOPMENT OF FARM BUILDINGS IN THE LANDSCAPE OF POLISH SPISZ ON THE EXAMPLE OF TRYBSZ VILLAGE

Piotr Herbut✉

Faculty of Environmental Engineering and Land Surveying, University of Agriculture in Krakow, Kraków

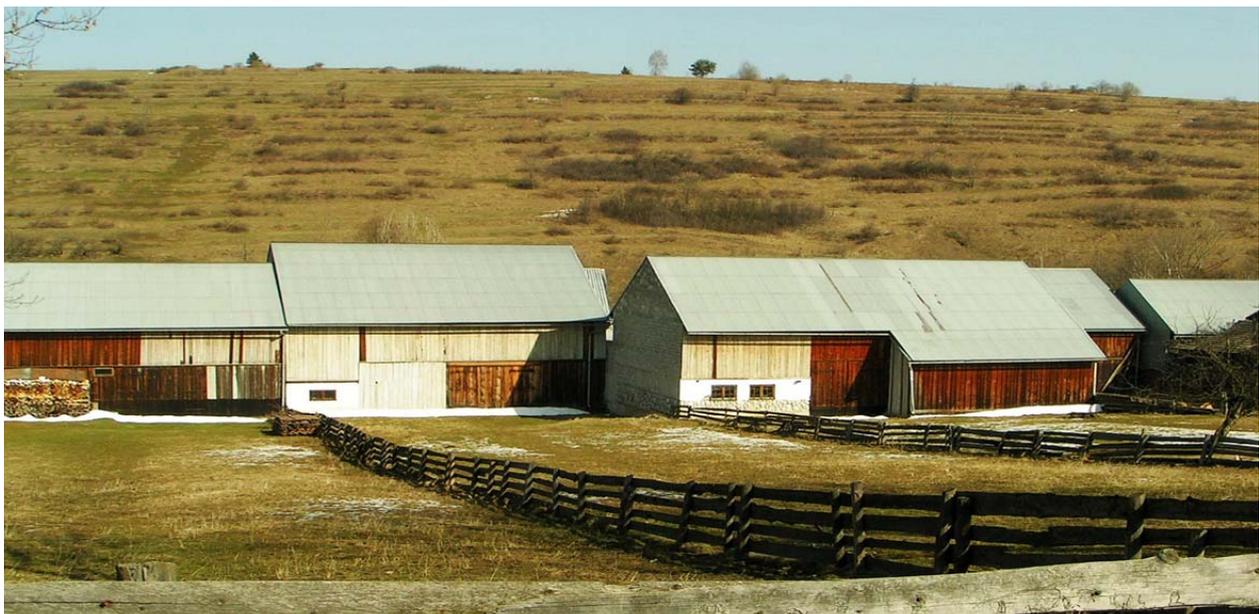
Fig. 3. A part of Trybsz with farm buildings at the back of residential plots, typical for Spisz villages (photo by P. Herbut)

Residential plots in the Trybsz village are relatively small in terms of their surface area, with densely-packed buildings. The results obtained indicate that, in Trybsz, approximately 80% of residential plots located in the historic part of the village have a plot ratio of about 0.8. Long and narrow plots with continuous rows of buildings along plot borders are a characteristic feature of land development in Trybsz village. On the farmyard side, buildings usually vary in width. Quite often at the back of residential plots, on the side of crop fields, a drive-through barn is situated, stretching across the entire width of the plot (Fig. 3).

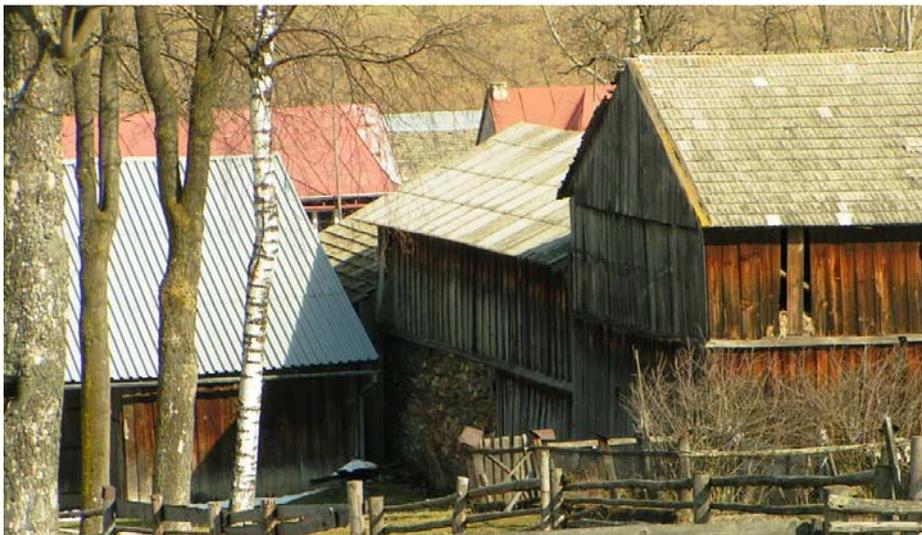
Fig. 4. Part of farm buildings in Trybsz, viewed from the south (photo by P. Herbut)

The fieldwork carried out has shown that, a typical architectural feature of farms in Spisz and in Trybsz village is that even though the buildings are situated adjacent to each other, their roof slopes and overhangs contrast with each other. Roofs may differ not only in their height and slope inclination parameters, but also in their form (pitched and monopitched, symmetric and asymmetric). In addition, sheeting materials usually differ as well (Fig. 4).

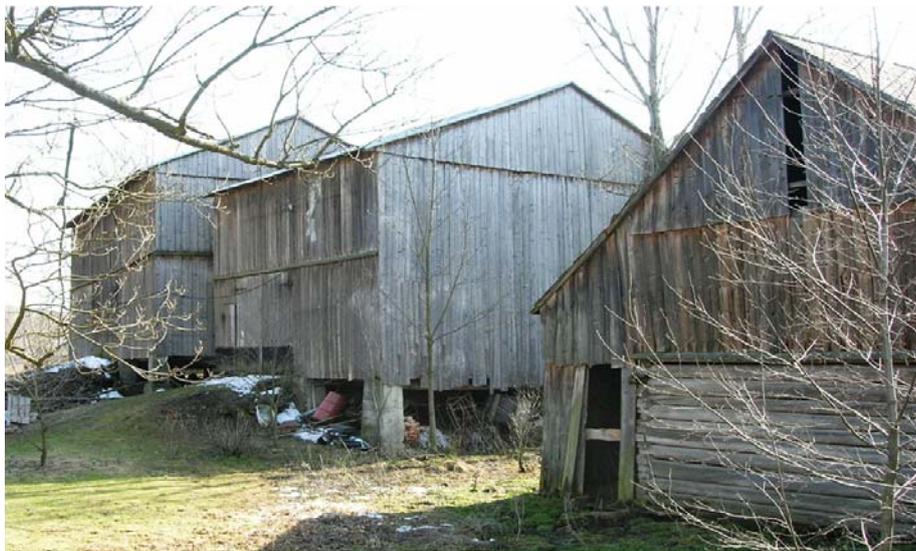
Fig. 6. Part of utility developments in Trybsz. In the foreground we can see a low building erected before 1950, while in the back there are more recent buildings with high knee walls (photo by P. Herbut)

The height of farm buildings began to increase in the 1950s. Thanks to elevation of knee walls, the height of buildings increased, thus increasing their storage capacity (Fig. 5b–5e). Currently, around 60% of utility buildings in Spisz are about 10 m in height, which means that they have doubled in size in comparison to the pre-war period (Fig. 6).

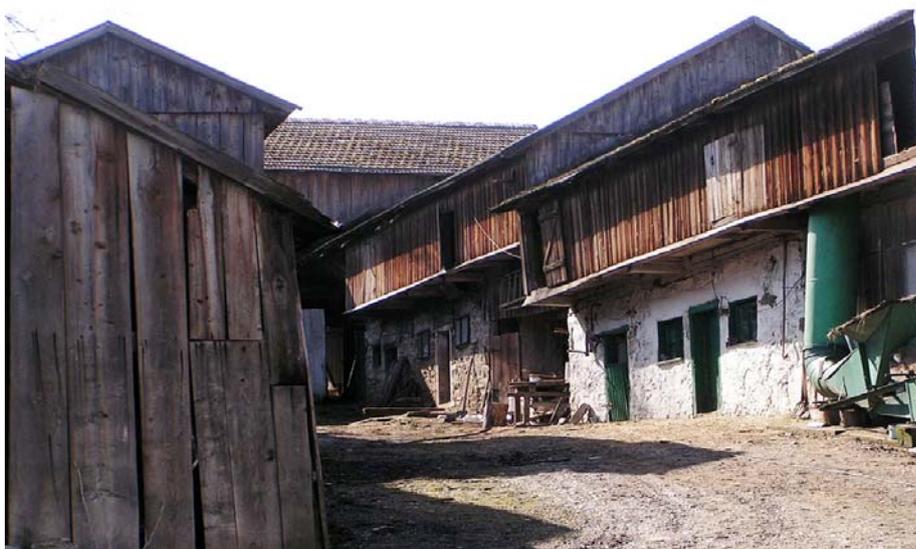
Fig. 7. Farmyard in the middle part of Trybsz. Visible overhanging attics over farm buildings (photo by P. Herbut)

When that was not enough, further enlargement of the cubic area was obtained by widening the attic in the cross-section of buildings (Figs. 5d, 5e). Such expansions were usually made by way of a unilateral overhang (of about 1.0–1.2 m) above the livestock building, situated towards the yard (Fig. 7).

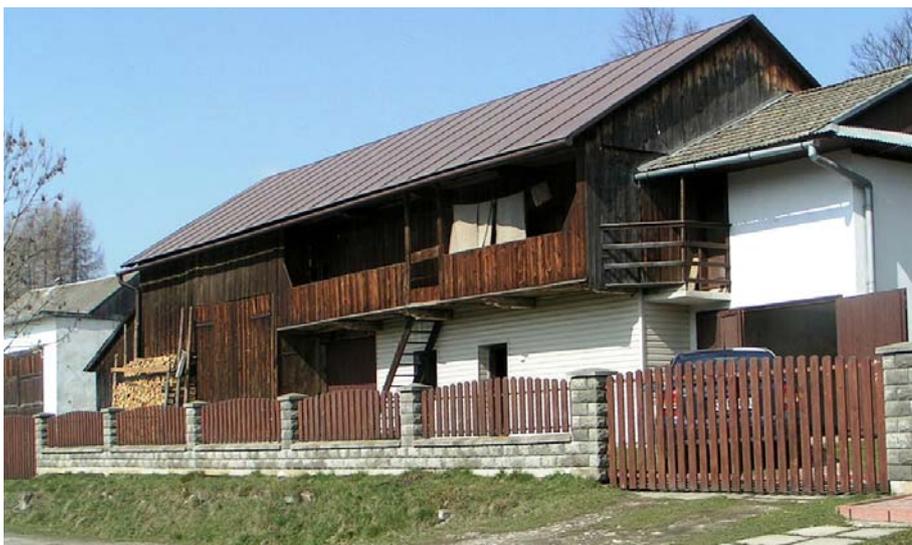
Fig. 8. Farmhouse with a gallery (photo by P. Herbut)

been automated with the use of hay and straw blowers, knee walls usually consisted of two doors. In one of them the blower's pipe was permanently fixed, while the other one was used to enter the attic. Therefore, the main purpose of a gallery was to improve access to the attic. This solution was of a great practical importance because it allowed farmers to choose the right variety of straw or hay for making feed or bedding from varieties placed in different parts of the utility attic of the farm building. In the wall separating the attic from the gallery one could usually find plank doors or openings, the number of which depended on the length of the attic. The gallery could be entered from the yard side using ladder-like stairs through an opening in the floor, sometimes with a trapdoor. The height of the gallery measured at its lowest point, i.e. at the balustrade, was usually 1.7–2.2 m. Whereas on the ground floor level, the attic gallery created an arcade used to store blowers, firewood, dog kennels etc. (Fig. 8).

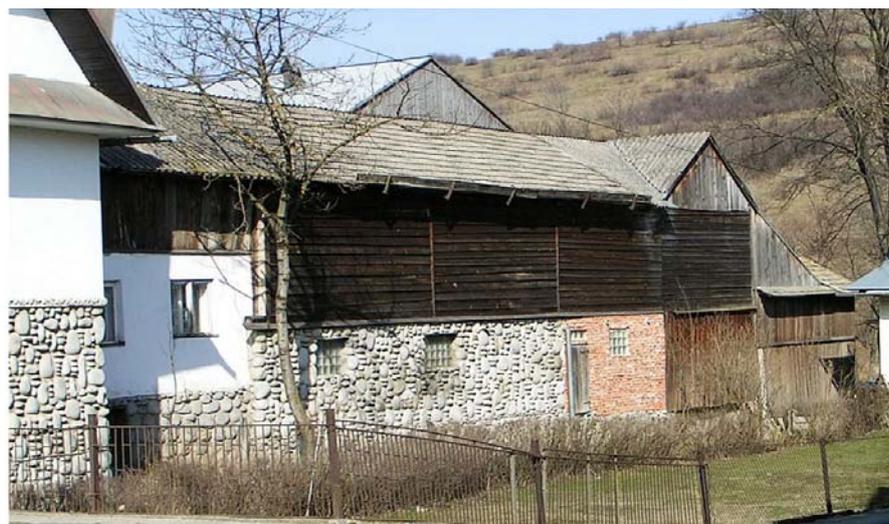
Fig. 9. The wall of a farm building in Trybsz with a high knee wall and various construction materials used (photo by P. Herbut)

lage. This mainly results from the fact that fires were a very frequent occurrence in the villages of Spisz. There were several occasions when fires destroyed wooden farm buildings in large parts of the villages (in the last 50 years: the great fire of Trybsz in 1950; fire in Frydman in 1982; in Niedzica in 1991) (Figiel, 1984). With subsidiary support from the state, villages affected by fires have been renovated, with a partial loss of their traditional architectural features, introducing new construction materials in the process. According to the analysis of study results, first farm buildings with high utility attics appeared back in the 1950s in burnt-out areas of the villages. During reconstruction works, not only was the appearance of farm buildings modified, but above all, numerous variations of roof types and building cross-sections were introduced in order to increase storage capacity. Non-combustible roof coverings such as cement and asbestos-cement products, which back then were the only available roof covering materials, were widely used and replaced laths and shingles almost completely (Fig. 9).
