DIGITAL SURVEY OF DAMAGES ON THE FAÇADE OF A HISTORICAL BUILDING

ABSTRACT

Researched object – a Castle Brewery

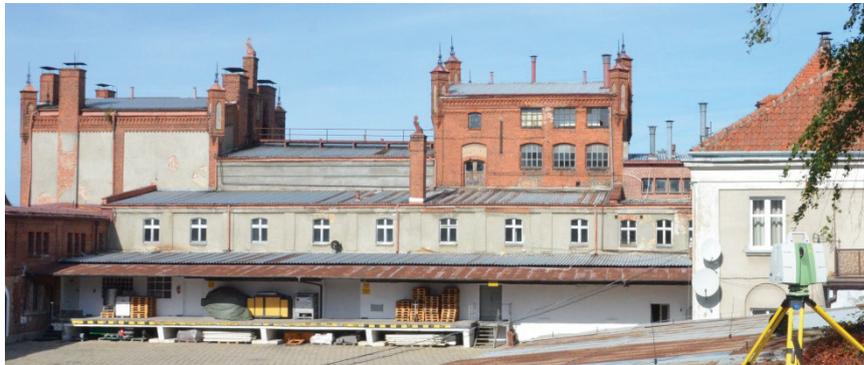
The research was carried out in the oldest part of the neo-gothic complex (Fig. 1). In 1996, this part of the building was entered into the register of historical buildings of the Warmińsko-Mazurskie Voivodeship.

Fig. 1. Laser scanner seen against the oldest part of the brewery – a view on the southern façade on the court side

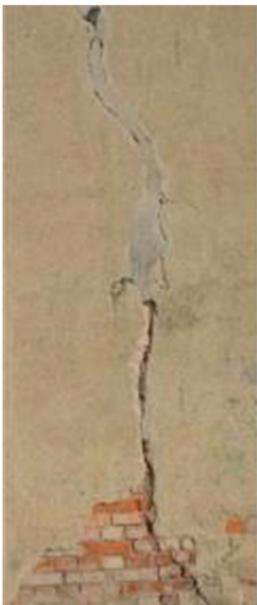
A crack extending from the ground level upwards was discovered on the eastern wall of the building (Fig. 3a). The crack was recorded during scanning. The scanner was placed 161 cm above the ground, 350 cm from the wall. The laser beam was projected at a 22-degree angle above the scanner lens axis and a 25-degree angle beneath it (Fig. 4). The crack can be clearly seen in the point cloud with a superimposed texture. The image of the crack can be easily measured in the point cloud (Fig. 3b). The crack is 300 cm long. It is 3 cm wide at its widest, and less than 1 cm wide at its narrowest point. The parameters of the crack are presented in the table.

Fig. 3a. Digital image of a portion of the crack

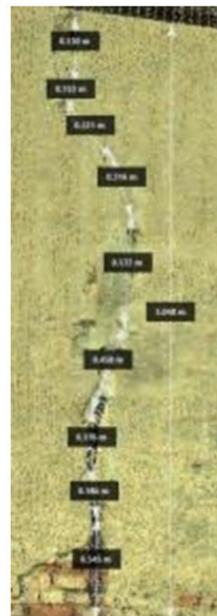
Fig. 3b. A portion of the crack mapped to a point cloud. The measurements are presented in the table

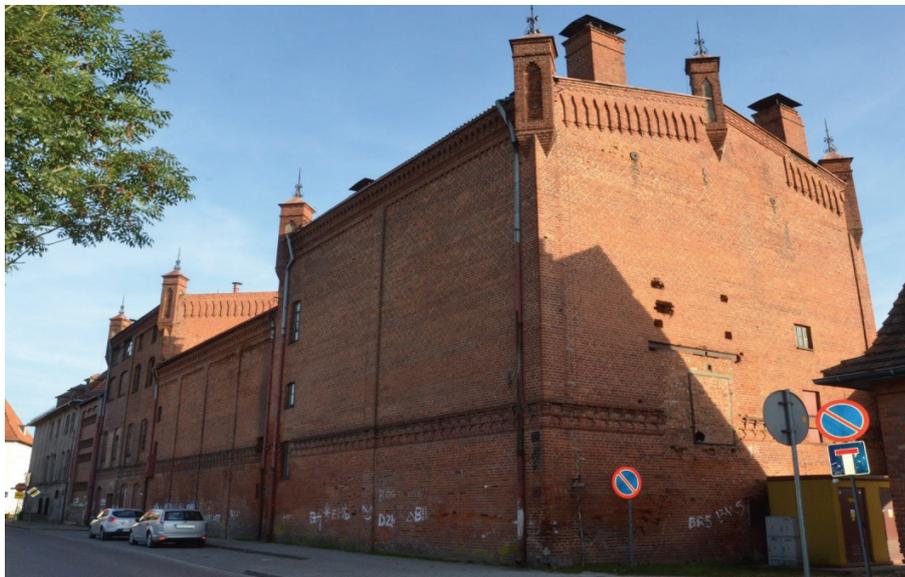
Numerous gaps were discovered in the upper portion of the western wall of the building. They are irregular in shape and result from crumbling or intentional removal of bricks (Fig. 5).

Fig. 5. The western façade with visible gaps

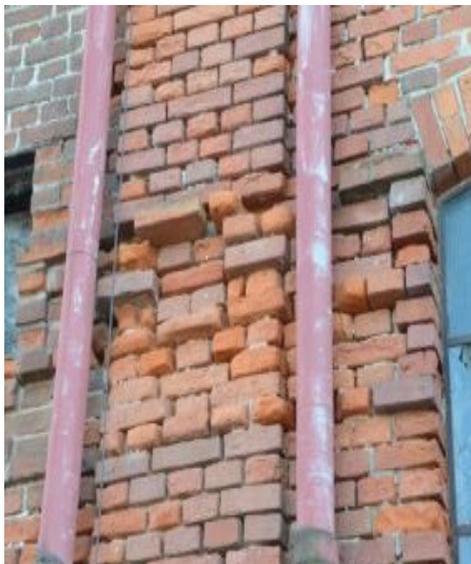
The southern façade seen from the court of the brewery compound. Numerous damages were observed here, caused mainly by water and wind. One of the analysed elements was a pillar between windows, featuring water-washed bricks and mortar joints (Fig. 9a). This condition of the pillar results probably from a leaky system for removing rainwater from the roof, causing the rainwater to flow out of

Fig. 9a. Digital image of the washed-out bricks and mortar joints
