## MAIN PHYSICAL-MECHANIC PROPERTIES OF CONCRETE SAMPLES TAKEN FROM BRAŽUOLĖ – FIRST REMOVED DAM IN LITHUANIA

According to historical records, the dam was first built in the 19<sup>th</sup> century to power a water mill. In this article, the main attention focused on the main physical-mechanic properties of concrete samples taken from Bražuolė dam – first officially removed dam in Lithuania (in 2020). The purpose of these investigations based on field research is to establish actual quantities of compression strength, density, and water absorption by weight of concrete used in the retaining walls of Bražuolė dam. The concrete water absorption by mass ( $W_m$ ) and compression strength ( $f_{ck}$ ) testing results based on research data of concrete samples from Bražuolė hydro-scheme retaining walls do not meet the requirements of currently valid technical construction regulation.

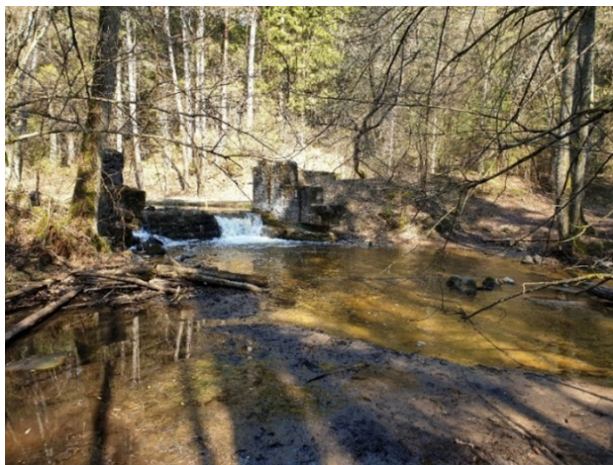
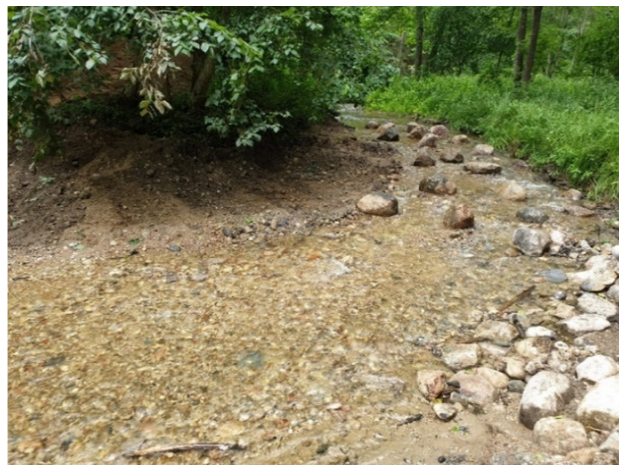
**Fig. 2.** Dam before and after removal

According to historical records, the dam was first built in the 19<sup>th</sup> century to power a water mill. The stone

step was 1 m high and 1 m wide and the total length of the dam was nearly 8 m. Initially, it was constructed from large boulders and wood but was rebuilt during the mid-20<sup>th</sup> century using mainly concrete. It eventually became obsolete and, without a registered owner, was abandoned for decades. The dam was situated on the 22.7-kilometer long river Bražuolė, which has an important role to play in the ecology of the area as it forms part of the Neris Regional Park, a Natura 2000 site. The dam was finally removed in July 2020 (Dam Removal Europe, 2021; Fig. 2).

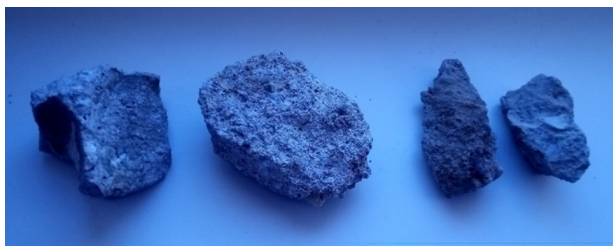
**Fig. 3.** Samples from concrete structures in Bražuolė hydroscheme

The samples from concrete hydraulic structures in Bražuolė hydroscheme (Fig. 3) were taken for a detailed investigation of the main physical-mechanic properties of concrete structures.

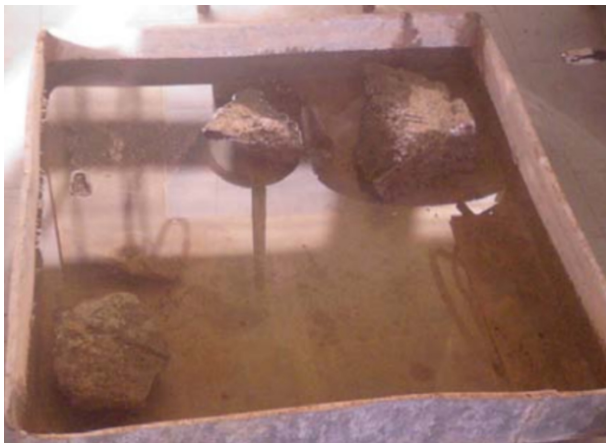
**Fig. 4.** Samples for the concrete water absorption by weight ( $W_m$ )

The samples from concrete hydraulic structures for evaluation of the concrete water absorption by weight ( $W_m$ ) were tested using methodology according to LST 1413.10:1997/P:2020 and EN 12390-8:2009 (Fig. 4).

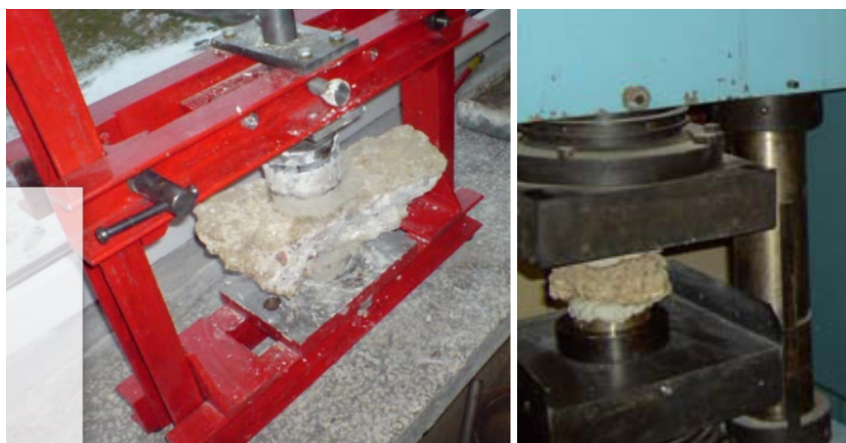
**Fig. 5.** Preparation for compression test of concrete irregular shape samples by concave punches and compression test of concrete by punches

The concrete samples were carefully inspected before the test. Cracked, layered, and with bubbles or pores samples were rejected. The test results are affected by the punches' diameter and the specimen height. Most of the concrete samples were of such a size that they could be tested with punches with the largest diameter ( $d = 100$  mm). Before the test, the cavities of the punches of the selected diameter are filled with a leveling mortar with a compressive strength close to that of the concrete under test. The sample is placed on one punch and the second punch goes on top of the sample, in that way the axes of the two punches coincide approximately. The samples were centered in a special device. The concrete compression strength of samples is evaluated by an ordinary compression test. For this purpose, hydraulic compression machines are used (Fig. 5).

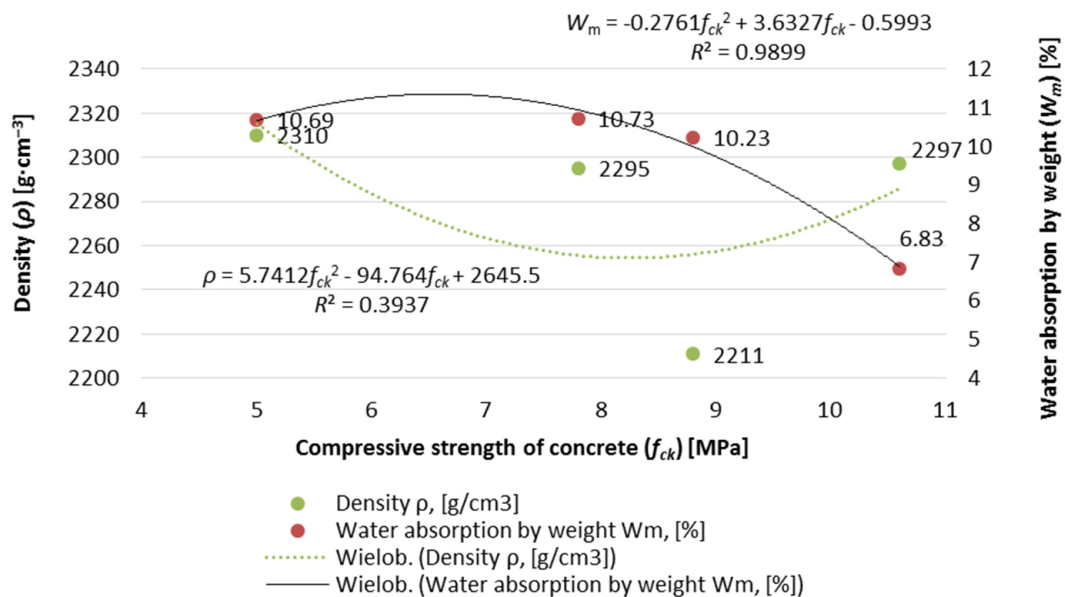
**Fig. 6.** Relationships between concrete samples water absorption by mass ( $W_m$ ) and average compression strength of concrete ( $f_{ck}$ ) and density ( $\rho$ ) – compression strength of concrete ( $f_{ck}$ )

Concrete average compression strength's ( $f_{ck}$ ), density ( $\rho$ ), and water absorption by mass ( $W_m$ ) functional dependencies were created (Fig. 6).

Concrete average compression strength's ( $f_{ck}$ ), concrete density ( $\rho$ ), and water absorption by mass ( $W_m$ ) reliability of functional dependencies were checked by double correlation. It was found, that dependences are strong ( $r_{xy} = 0.98$ ) and medium ( $r_{xy} = 0.4$ ). Calculated correlation coefficients are reliable, their importance level  $p < 0.05$ . The established determination coefficient  $R^2 = 0.9899$ , therefore can be stated that examined strength parameters influence investigated water absorption by 98.99%, another part belongs to the influence of less important parameters. The established determination coefficient  $R^2 = 0.3937$  shows strength parameters influence density by 39.37%.
