EVALUATION OF THE DAMAGE AND REINFORCEMENT OF THE FOUNDATION IN A TEN-STOREY MULTI-PURPOSE BUILDING IN PORT HARCOURT, RIVERS STATE, NIGERIA

Isaac Agbamu

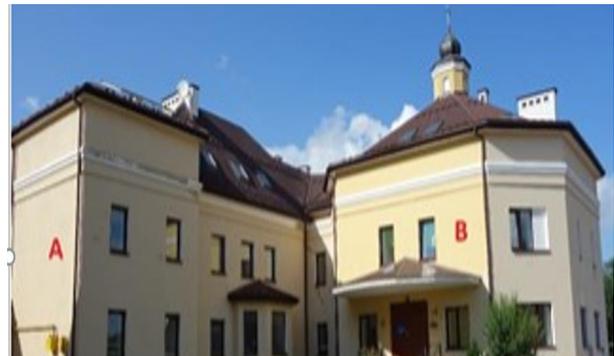
Figure 1 shows part of the layout of the building and the knowledge gained during the on-site inspection gave worrying indications that the bell tower and rectory had already settled unevenly during construction.

Fig. 1. Buildings' layout: A – the northern part; B – the southern part of the multi-storey building at Port Harcourt (photo by the author)

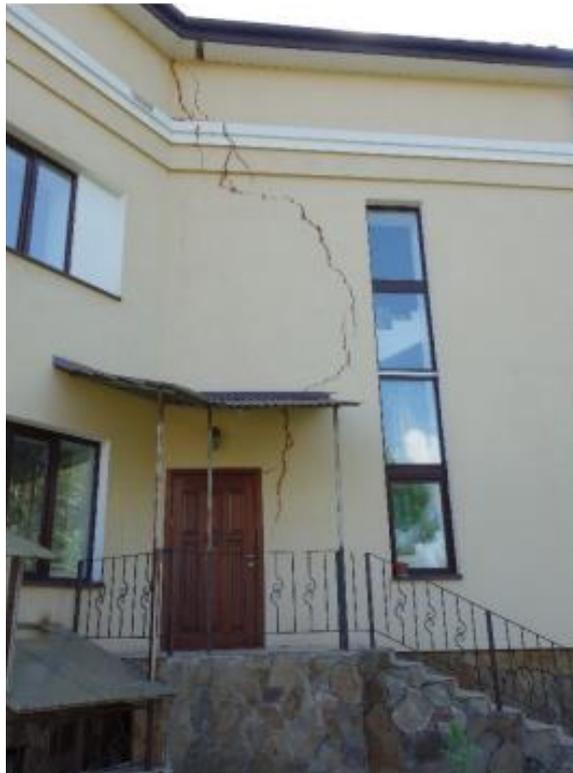
After the completion of the construction work, the walls and ceiling of the vicarage showed cracks 3–5 cm wide (Fig. 2). Figure 3 shows cracks that are visible on the walls of the garage next to Part A of the vicarage. The cracks and scratches that appeared are still spreading. However, no scratches were found on the walls of the church. The inspection also revealed another problem that is crucial for the operation of the building, namely the high level of moisture in the basement walls.

Fig. 2. Scratches of the external bearing wall of the linking part between the northern and southern part of the building (photo by the author)

The selection of the concept for the reconstruction of the building is determined by the distribution and nature of the scratches, the diversification of the depth at which parts of the building (A or B) were placed and the different conditions of the subsoil affect the foundations of the A and B Part of buildings. After examining the above factors, it was concluded that two different rehabilitation methods should be considered and developed for the separate building parts (A and B).

in Part B. For part A of the building, the structural reinforcements in the areas of cracks and scratches in the walls are sufficient and necessary.

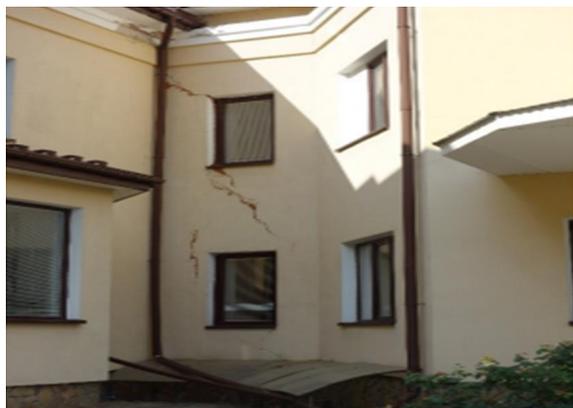
Fig. 3. Cracks/collapse on the external wall of the staircase at the multi-storey building at Port Harcourt (photo by the author)
