## HAZARDS RESULTING FROM IMPROPER BUILDING DRAINAGE SYSTEM BY THE USE OF BIM

Grzegorz Wrzeński ✉

Institute of Civil Engineering, Warsaw University of Life Sciences – SGGW

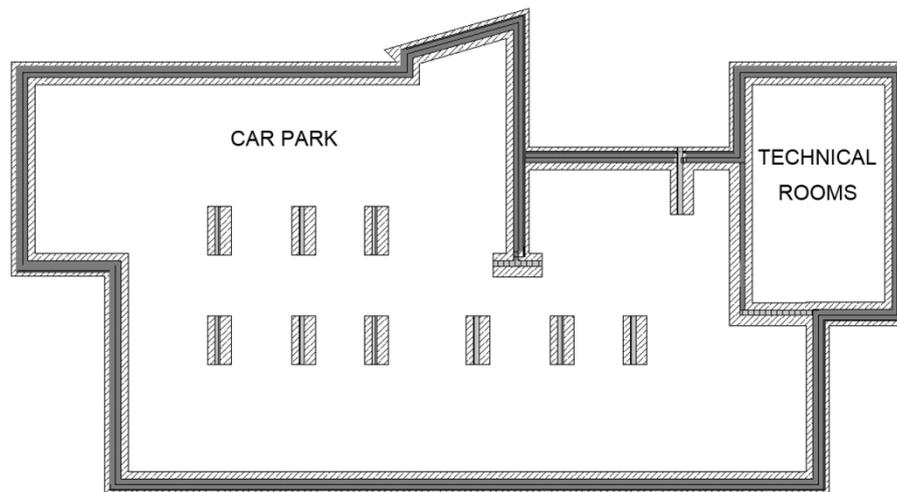
**Fig. 2.** Level -1 of the analysed residential building

as a reference for the planned project of the building and the possible changes were not taken into account. After a few years of object utilization, the water level increased by about 1.0 m and the water began to infiltrate the underground part of the building. In some periods, the water level in the underground part of the building rose to 0.3 m above the floor. Flooding of the underground part of the building rendered the use of the underground car park impossible and caused damage to the technical equipment on level -1.
